Customer Id: CHUANN
Sample No.: WC0836524
Lab Number: 05959142
Test Package: PLANT

OIL ANALYSIS REPORT

Machine Id
[] WC-9700B-0102-5 Chiller #2
Component
Chiller
Fluid
NOT GIVEN (--- GAL)

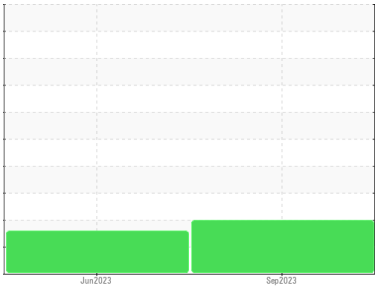
Sample Rating Trend

Wear
The copper level is abnormal. All other component wear rates are normal.

Contamination
There is a high amount of silt (particulates < 14 microns in size) present in the oil.

No corrective action is recommended at this time. We recommend an early resample to monitor this condition. Please specify the brand, type, and viscosity of the oil on your next sample.

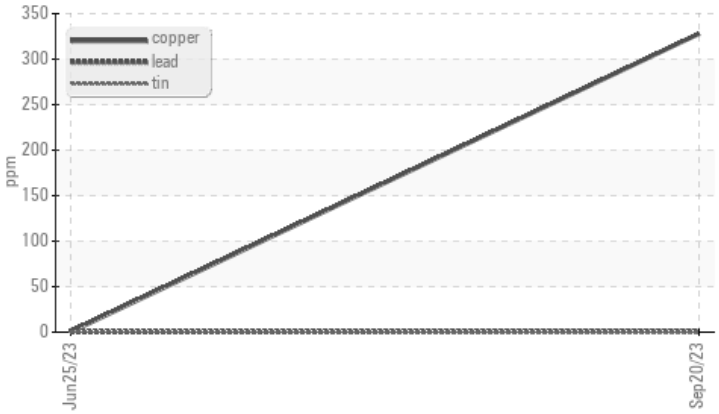
▲ Non-ferrous Metals

Sample Status				**ABNORMAL**	ABNORMAL	---
Copper	ppm	ASTM D5185m	>8	▲ **328**	<1	---
Particles >4µm		ASTM D7647	>10000	▲ **53425**	3806	---
Particles >6µm		ASTM D7647	>2500	▲ **5237**	830	---
Oil Cleanliness		ISO 4406 (c)	>20/18/15	▲ **23/20/12**	19/17/12	---

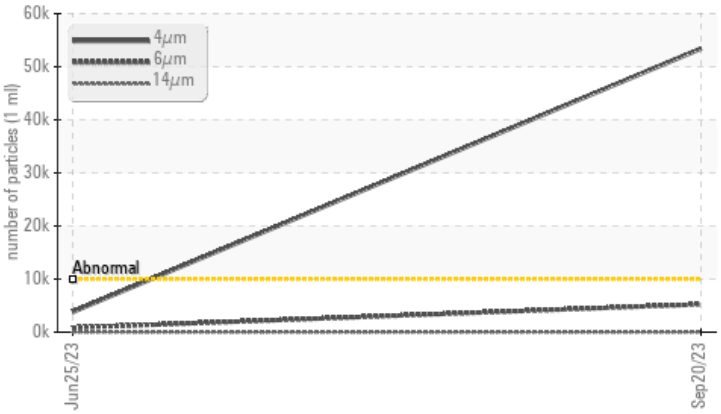
▲ Particle Trend

FLUID CLEANLINESS		method	limit/base	current	history1	history2
Particles >4µm		ASTM D7647	>10000	▲ **53425**	3806	---
Particles >6µm		ASTM D7647	>2500	▲ **5237**	830	---
Particles >14µm		ASTM D7647	>320	**26**	30	---
Particles >21µm		ASTM D7647	>80	**4**	5	---
Particles >38µm		ASTM D7647	>20	**1**	0	---
Particles >71µm		ASTM D7647	>4	**1**	0	---
Oil Cleanliness		ISO 4406 (c)	>20/18/15	▲ **23/20/12**	19/17/12	---

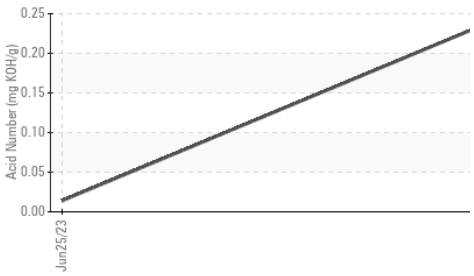
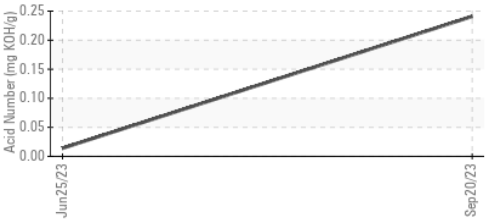
Acid Number

Fluid Condition
The AN level is acceptable for this fluid. The condition of the oil is suitable for further service.
