Area
NOT GIVEN [10195554]
Machine Id
SULLAIR 003-62385 - DETYENS SHIPYARD
Component
Compressor

Customer Id: UCFLUMAN
Sample No.: UCH05959892
Lab Number: 05959892
Test Package: IND 2

OIL ANALYSIS REPORT

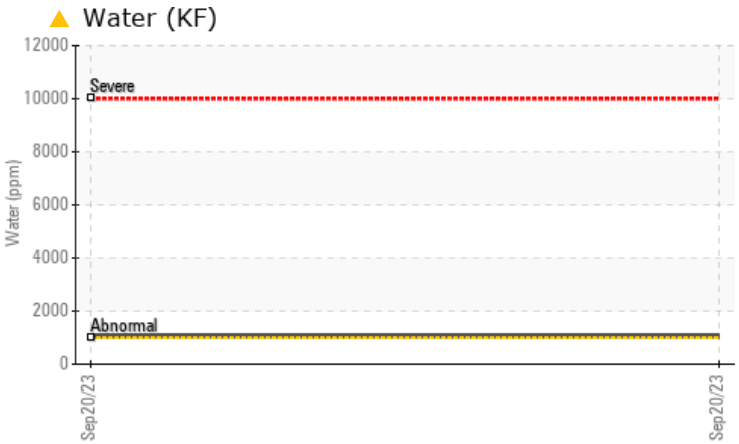
COMPONENT CONDITION SUMMARY

Sample Status				**ATTENTION**	---	---
Water	%	ASTM D6304	>0.1	▲ **0.105**	---	---
ppm Water	ppm	ASTM D6304	>1000	▲ **1050**	---	---
Emulsified Water	scalar	*Visual	>0.1	▲ **0.2%**	---	---

Contamination
Moderate concentration of visible dirt/debris present in the oil. There is a light concentration of water present in the oil.

We advise that you follow the water drain-off procedure for this component. Resample at the next service interval to monitor.
