# PROBLEM SUMMARY

Machine Id
**8024406 (S/N 1186)**
Component
**Compressor**
Fluid
**KAESER SIGMA (OEM) S-460 (--- QTS)**

# OIL ANALYSIS REPORT

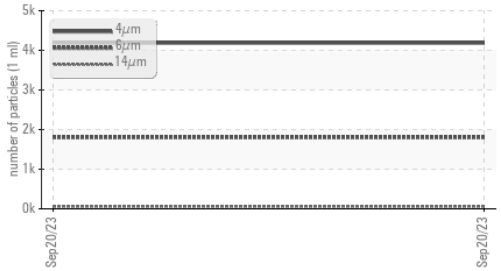
Particle Trend

**Contamination**
There is a moderate amount of particulates present in the oil.

| FLUID CLEANLINESS | | method | limit/base | current | history1 | history2 |
|---|---|---|---|---|---|---|
| Particles >6µm | | ASTM D7647 | >1300 | ▲ **1804** | --- | --- |
| Oil Cleanliness | | ISO 4406 (c) | >--/17/13 | ▲ **19/18/13** | --- | --- |

**Recommendation**
The filter change at the time of sampling has been noted. Resample at the next service interval to monitor.
