Area
IRON STAR [200006142]
Machine Id
15WEA88308
Component
Wind Turbine Gearbox
Fluid
GEAR OIL (PAO) ISO 320 (--- LTR)

OIL ANALYSIS REPORT

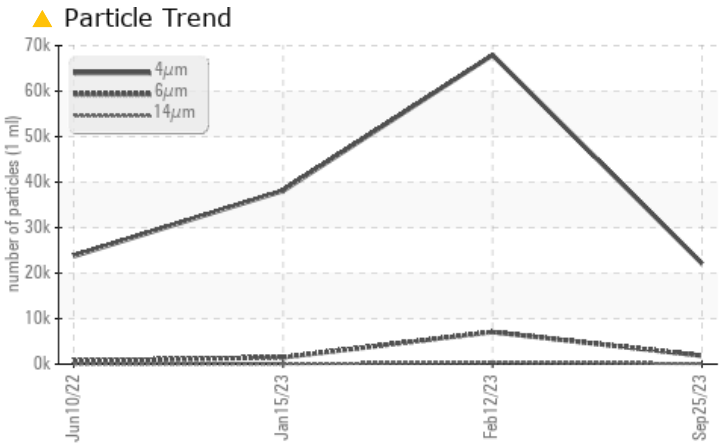
COMPONENT CONDITION SUMMARY

Sample Status				ABNORMAL	ABNORMAL	ABNORMAL
Particles >6µm		ASTM D7647	>320	▲ **1850**	▲ 7052	▲ 1484
Particles >14µm		ASTM D7647	>40	▲ **119**	▲ 323	▲ 77
Particles >21µm		ASTM D7647	>10	▲ **25**	▲ 69	▲ 23
Oil Cleanliness		ISO 4406 (c)	>--/15/12	▲ **22/18/14**	▲ 23/20/16	▲ 22/18/13

Contamination
There is a high amount of particulates present in the oil.

We recommend you service the filters on this component if applicable. Resample at the next service interval to monitor.

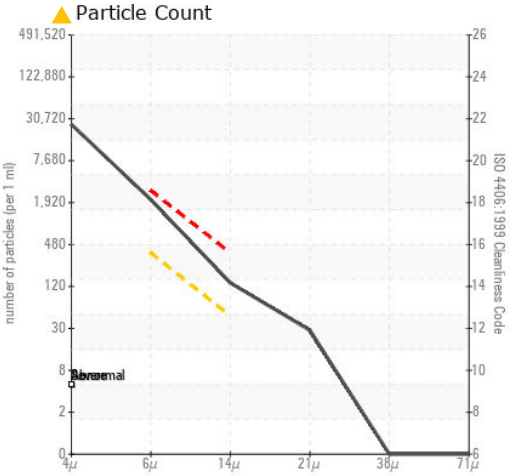
Particle Count

FLUID CLEANLINESS		method	limit/base	current	history1	history2
Particles >4µm		ASTM D7647		**22110**	67924	38115
Particles >6µm		ASTM D7647	>320	▲ **1850**	▲ 7052	▲ 1484
Particles >14µm		ASTM D7647	>40	▲ **119**	▲ 323	▲ 77
Particles >21µm		ASTM D7647	>10	▲ **25**	▲ 69	▲ 23
Particles >38µm		ASTM D7647	>3	**0**	2	1
Particles >71µm		ASTM D7647	>3	**0**	1	0
Oil Cleanliness		ISO 4406 (c)	>--/15/12	▲ **22/18/14**	▲ 23/20/16	▲ 22/18/13

Recommendation
We recommend you service the filters on this component if applicable. Resample at the next service interval to monitor.
