Customer Id: HILDAL
Sample No.: USP0001903
Lab Number: 05961272
Test Package: IND 2

OIL ANALYSIS REPORT

Machine Id
CHEESE SEALER D
Component
Vacuum Pump
Fluid
NOT GIVEN (--- GAL)

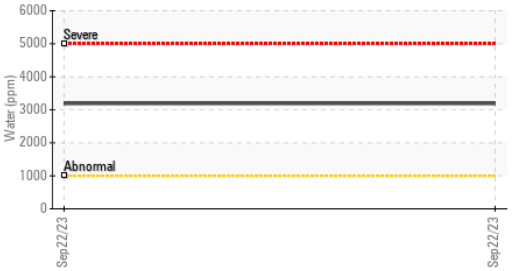
Water (KF)

Appearance is unacceptable. There is a high amount of visible silt present in the sample. Excessive free water present.

CONTAMINANTS		method	limit/base	current	history1	history2
Silicon	ppm	ASTM D5185m	>15	**4**	---	---
Sodium	ppm	ASTM D5185m		**0**	---	---
Potassium	ppm	ASTM D5185m	>20	**0**	---	---
Water	%	ASTM D6304	>.1	▲ **0.319**	---	---
ppm Water	ppm	ASTM D6304	>1000	▲ **3190**	---	---

We advise that you follow the water drain-off procedure for this component. We recommend an early resample to monitor this condition. We were unable to perform a particle count due to a high concentration of particles and water present in this sample.

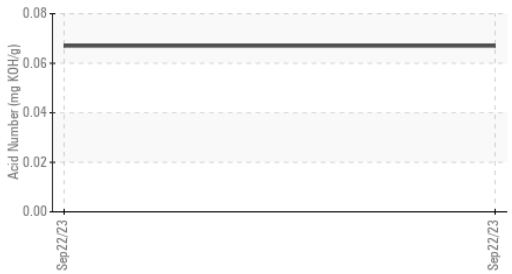
Confirm oil type. The AN level is acceptable for this fluid.

FLUID DEGRADATION		method	limit/base	current	history1	history2
Acid Number (AN)	mg KOH/g	ASTM D8045		**0.067**	---	---

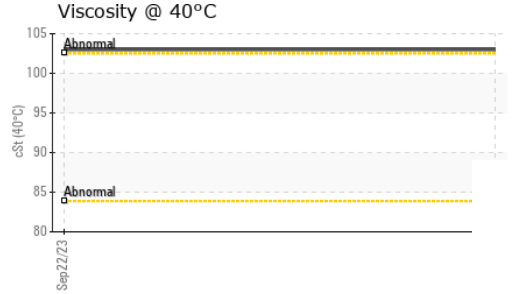
Viscosity @ 40°C

FLUID PROPERTIES		method	limit/base	current	history1	history2
Visc @ 40°C	cSt	ASTM D445		**103**	---	---
