Machine Id
KAESER SM-11 2143835 (S/N 1314)
Component
Compressor
Fluid
KAESER SIGMA (OEM) S-460 (--- GAL)

Customer Id: BRYLAW
Sample No.: KCPA004765
Lab Number: 05961756
Test Package: IND 2

OIL ANALYSIS REPORT

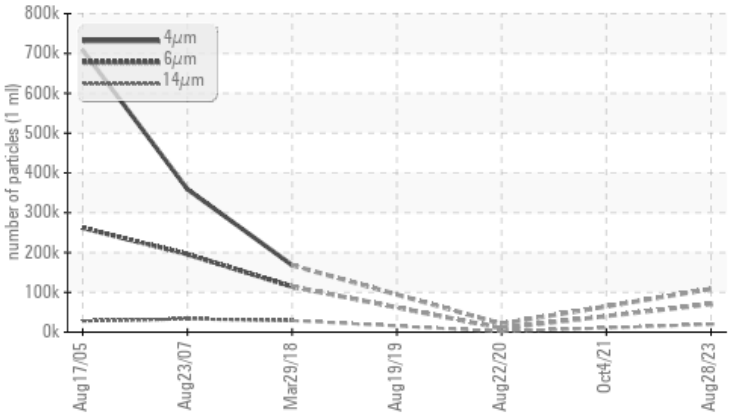
Particle Trend

Sample Status				ABNORMAL	ABNORMAL	ABNORMAL
Particles >6µm		ASTM D7647	>1300	▲ **70727**	---	▲ 9698
Particles >14µm		ASTM D7647	>80	▲ **19562**	---	▲ 1839
Particles >21µm		ASTM D7647	>20	▲ **7493**	---	▲ 639
Particles >38µm		ASTM D7647	>4	▲ **316**	---	▲ 49
Particles >71µm		ASTM D7647	>3	▲ **9**	---	1
Oil Cleanliness		ISO 4406 (c)	>--/17/13	▲ **24/23/21**	---	▲ 20/18

▲ Contamination
There is a high amount of particulates present in the oil.

No corrective action is recommended at this time. The filter change at the time of sampling has been noted. Resample at the next service interval to monitor.

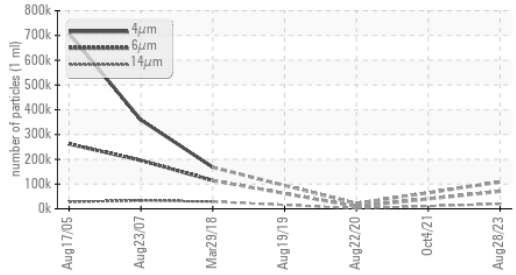
Particle Trend

FLUID CLEANLINESS		method	limit/base	current	history1	history2
Particles >4µm		ASTM D7647		**108595**	---	20842
Particles >6µm		ASTM D7647	>1300	▲ **70727**	---	▲ 9698
Particles >14µm		ASTM D7647	>80	▲ **19562**	---	▲ 1839
Particles >21µm		ASTM D7647	>20	▲ **7493**	---	▲ 639
Particles >38µm		ASTM D7647	>4	▲ **316**	---	▲ 49
Particles >71µm		ASTM D7647	>3	▲ **9**	---	1
Oil Cleanliness		ISO 4406 (c)	>--/17/13	▲ **24/23/21**	---	▲ 20/18
