Machine Id
BUSCH VP-8C (S/N 5602374)
Component
Vacuum Pump
Fluid
USPI VAC 100 (--- GAL)

Customer Id: TYSAMAPRO
Sample No.: USPM29769
Lab Number: 05961769
Test Package: IND 2

OIL ANALYSIS REPORT

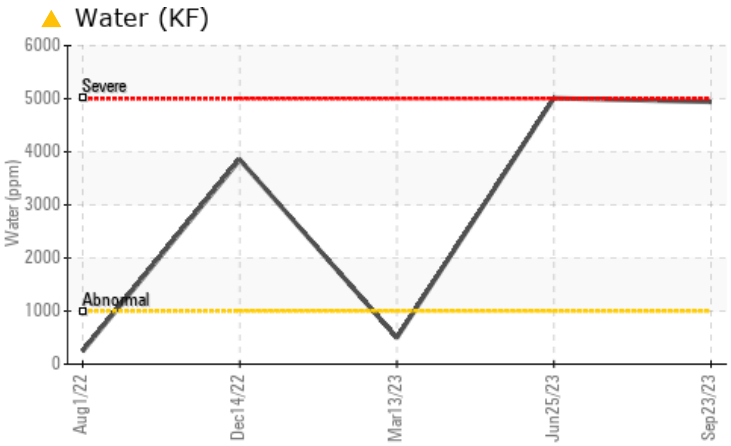
COMPONENT CONDITION SUMMARY

WATER

Sample Status				ABNORMAL	ABNORMAL	NORMAL
Water	%	ASTM D6304	>.1	▲ **0.494**	▲ 0.501	0.049
ppm Water	ppm	ASTM D6304	>1000	▲ **4940**	▲ 5010	497.7

We advise that you follow the water drain-off procedure for this component. Resample at the next service interval to monitor.

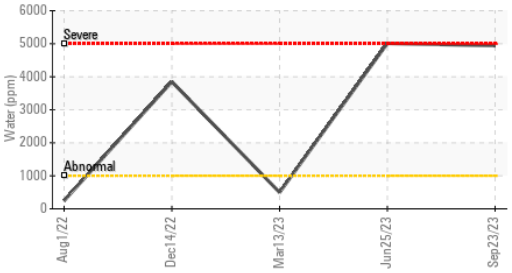
Water (KF)

Contamination
There is a moderate concentration of water present in the oil. The amount and size of particulates present in the system are acceptable.

CONTAMINANTS		method	limit/base	current	history1	history2
Silicon	ppm	ASTM D5185m	>15	**9**	8	8
Sodium	ppm	ASTM D5185m		**0**	0	0
Potassium	ppm	ASTM D5185m	>20	**2**	<1	<1
Water	%	ASTM D6304	>.1	▲ **0.494**	▲ 0.501	0.049
ppm Water	ppm	ASTM D6304	>1000	▲ **4940**	▲ 5010	497.7

Recommendation
We advise that you follow the water drain-off procedure for this component. Resample at the next service interval to monitor.
