# PROBLEM SUMMARY

Machine Id
## BUSCH WENDYS PUMP 3 (DOWNSTAIRS) (S/N 5593913)
Component
**Vacuum Pump**
Fluid
**USPI VAC 100 (--- GAL)**

# OIL ANALYSIS REPORT

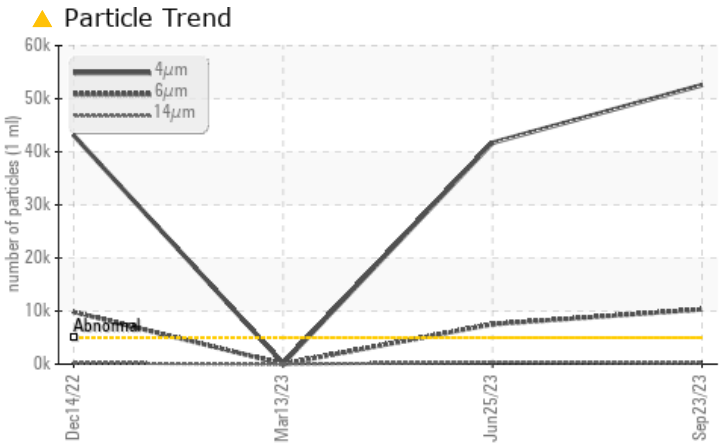
## COMPONENT CONDITION SUMMARY

**Contamination**
There is a high amount of particulates present in the oil.

We recommend you service the filters on this component. Resample at the next service interval to monitor.

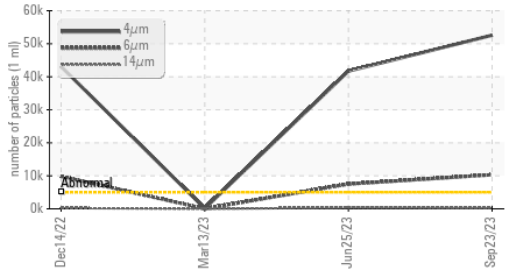
Particle Trend

| FLUID CLEANLINESS | | method | limit/base | current | history1 | history2 |
|---|---|---|---|---|---|---|
| Particles >4µm | | ASTM D7647 | >5000 | ▲ **52577** | ▲ 41713 | 111 |
| Particles >6µm | | ASTM D7647 | >1300 | ▲ **10312** | ▲ 7520 | 27 |
| Particles >14µm | | ASTM D7647 | >160 | ▲ **195** | ▲ 344 | 4 |
| Oil Cleanliness | | ISO 4406 (c) | >19/17/14 | ▲ **23/21/15** | ▲ 23/20/16 | 14/12/9 |

**Recommendation**
We recommend you service the filters on this component. Resample at the next service interval to monitor.

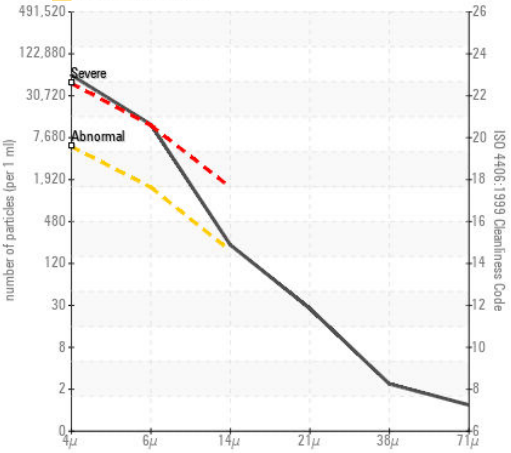
Particle Count

| Sample Status | | | | ABNORMAL | ABNORMAL | NORMAL |
|---|---|---|---|---|---|---|
| Particles >4µm | | ASTM D7647 | >5000 | ▲ **52577** | ▲ 41713 | 111 |
| Particles >6µm | | ASTM D7647 | >1300 | ▲ **10312** | ▲ 7520 | 27 |
| Particles >14µm | | ASTM D7647 | >160 | ▲ **195** | ▲ 344 | 4 |
| Oil Cleanliness | | ISO 4406 (c) | >19/17/14 | ▲ **23/21/15** | ▲ 23/20/16 | 14/12/9 |
