LESLIE EQUIPMENT CO.

PROBLEM SUMMARY

Area
{unassigned}
Machine Id
JOHN DEERE 950K 1T0950KPVJF339846
Component
Hydraulic System
Fluid
JOHN DEERE HYDRAU (23 GAL)

OIL ANALYSIS REPORT

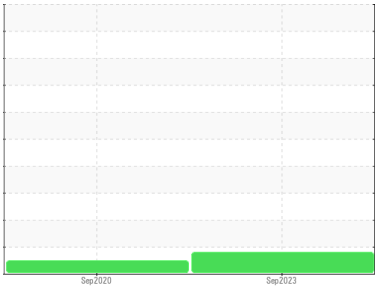
Sample Rating Trend

WEAR

▲ Ferrous Alloys

Sample Status				**ABNORMAL**	NORMAL	---
Iron	ppm	ASTM D5185m	>23	▲ **29**	5	---

No corrective action is recommended at this time.
Resample at the next service interval to monitor.

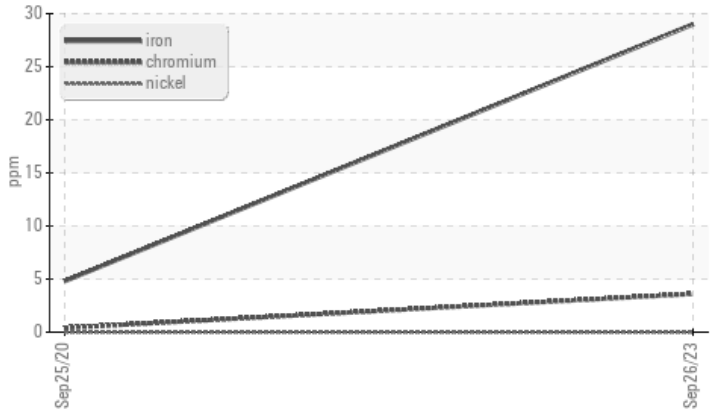
COMPONENT CONDITION SUMMARY

Wear
The iron level is abnormal. All other component wear rates are normal.
