Hilcorp Alaska, LLC

PROBLEM SUMMARY

Area
IRIG [6076665]
Machine Id
IRIG-PIP-HPU-2001 IRIG-PIP-HPU-2001 HPU PIPE SHED MODULE
Component
Hydraulic System
Fluid
MOBIL DTE 10 EXCEL 32 (140 GAL)

OIL ANALYSIS REPORT

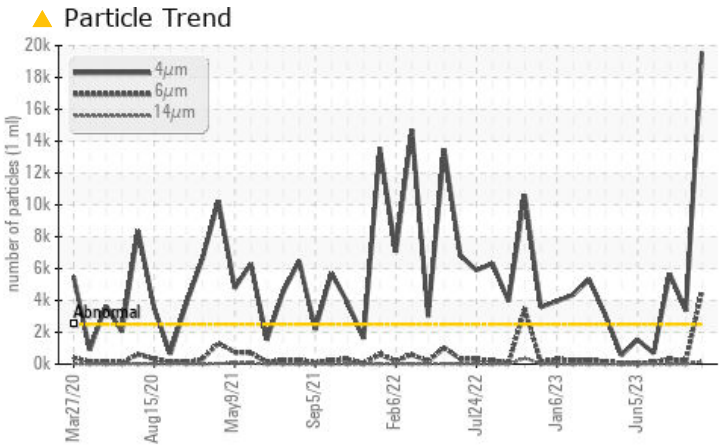
COMPONENT CONDITION SUMMARY

Sample Status				ABNORMAL	ATTENTION	ABNORMAL
Particles >4µm		ASTM D7647	>2500	▲ **19570**	▲ 3351	▲ 5673
Particles >6µm		ASTM D7647	>640	▲ **4573**	183	330
Particles >14µm		ASTM D7647	>80	▲ **161**	6	10
Oil Cleanliness		ISO 4406 (c)	>18/16/13	▲ **21/19/15**	▲ 19/15/10	▲ 20/16/10

There is a moderate amount of silt (particulates < 14 microns in size) present in the oil. The system cleanliness is above the acceptable limit for the target ISO 4406 cleanliness code.

We recommend you service the filters on this component. We recommend an early resample to monitor this condition.

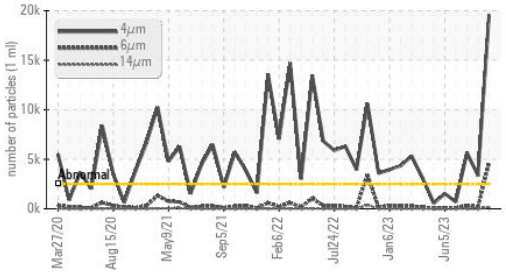
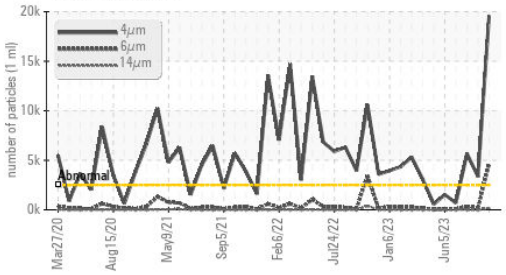
Particle Trend

FLUID CLEANLINESS		method	limit/base	current	history1	history2
Particles >4µm		ASTM D7647	>2500	▲ **19570**	▲ 3351	▲ 5673
Particles >6µm		ASTM D7647	>640	▲ **4573**	183	330
Particles >14µm		ASTM D7647	>80	▲ **161**	6	10
Particles >21µm		ASTM D7647	>20	**28**	2	2
Particles >38µm		ASTM D7647	>4	**1**	0	0
Particles >71µm		ASTM D7647	>3	**0**	0	0
Oil Cleanliness		ISO 4406 (c)	>18/16/13	▲ **21/19/15**	▲ 19/15/10	▲ 20/16/10

We recommend you service the filters on this component. We recommend an early resample to monitor this condition.

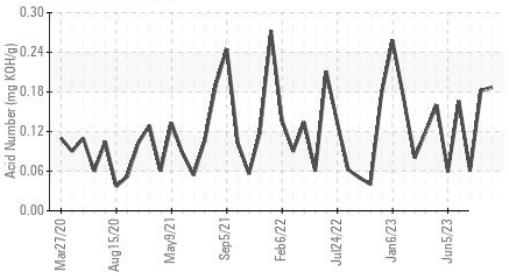
Acid Number

The AN level is acceptable for this fluid. The oil is still serviceable provided that the contaminant(s) can be reduced to acceptable levels.

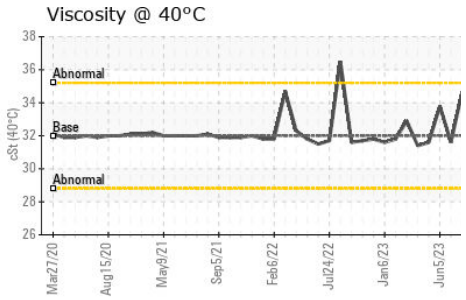
Viscosity @ 40°C

FLUID PROPERTIES		method	limit/base	current	history1	history2
Visc @ 40°C	cSt	ASTM D445	32	**32.3**	31.7	34.6
