Hilcorp Alaska, LLC

PROBLEM SUMMARY

Area
IRIG [6076658]
Machine Id
IRIG-CWU-HPU-2101 IRIG-CWU-HPU-2101 HPU CATWALK
Component
Hydraulic System
Fluid
MOBIL DTE 10 EXCEL 32 (120 GAL)

OIL ANALYSIS REPORT

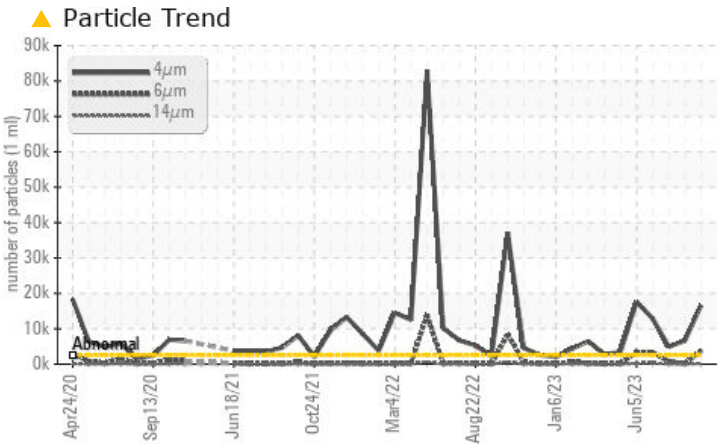
COMPONENT CONDITION SUMMARY

Sample Status				ABNORMAL	ABNORMAL	ATTENTION
Particles >4µm		ASTM D7647	>2500	▲ **16544**	▲ 6621	▲ 4921
Particles >6µm		ASTM D7647	>640	▲ **3780**	149	▲ 731
Particles >14µm		ASTM D7647	>80	▲ **162**	10	38
Particles >21µm		ASTM D7647	>20	▲ **29**	4	9
Oil Cleanliness		ISO 4406 (c)	>18/16/13	▲ **21/19/15**	▲ 20/14/10	▲ 19/17/12

There is a moderate amount of silt (particulates < 14 microns in size) present in the oil. The system cleanliness is above the acceptable limit for the target ISO 4406 cleanliness code.

We recommend you service the filters on this component. We recommend an early resample to monitor this condition.

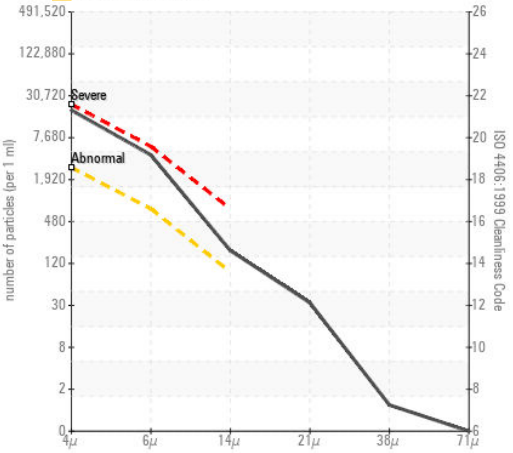
Particle Count

FLUID CLEANLINESS		method	limit/base	current	history1	history2
Particles >4µm		ASTM D7647	>2500	▲ **16544**	▲ 6621	▲ 4921
Particles >6µm		ASTM D7647	>640	▲ **3780**	149	▲ 731
Particles >14µm		ASTM D7647	>80	▲ **162**	10	38
Particles >21µm		ASTM D7647	>20	▲ **29**	4	9
Particles >38µm		ASTM D7647	>4	**1**	0	0
Particles >71µm		ASTM D7647	>3	**0**	0	0
Oil Cleanliness		ISO 4406 (c)	>18/16/13	▲ **21/19/15**	▲ 20/14/10	▲ 19/17/12

We recommend you service the filters on this component. We recommend an early resample to monitor this condition.
