Machine Id
BOOSTER 2 - 920481
Component
Refrigeration Compressor
Fluid
REFRIG COMP OIL ISO 68 (--- GAL)

Customer Id: AMEEAS_USP
Sample No.: USP0001816
Lab Number: 05964228
Test Package: IND 2

OIL ANALYSIS REPORT

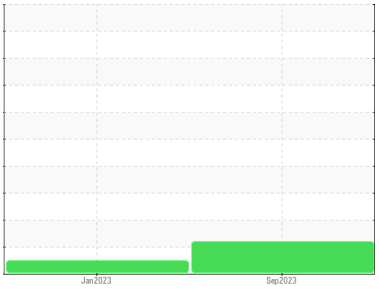
Sample Rating Trend

Sample Status				**ABNORMAL**	NORMAL	---
Particles >4µm		ASTM D7647	>10000	▲ **26886**	6154	---
Particles >6µm		ASTM D7647	>2500	▲ **4543**	1301	---
Oil Cleanliness		ISO 4406 (c)	>20/18/15	▲ **22/19/14**	20/18/12	---

Contamination
There is a high amount of silt (particulates < 14 microns in size) present in the oil.

Resample at the next service interval to monitor.

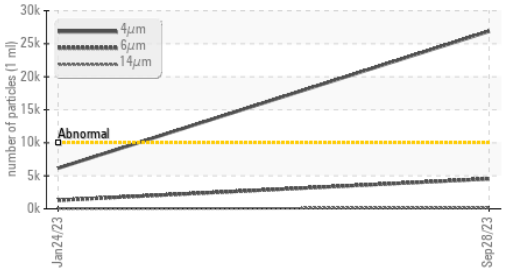
Particle Trend

FLUID CLEANLINESS		method	limit/base	current	history1	history2
Particles >4µm		ASTM D7647	>10000	▲ **26886**	6154	---
Particles >6µm		ASTM D7647	>2500	▲ **4543**	1301	---
Particles >14µm		ASTM D7647	>320	**127**	38	---
Particles >21µm		ASTM D7647	>80	**21**	6	---
Particles >38µm		ASTM D7647	>20	**0**	1	---
Particles >71µm		ASTM D7647	>4	**0**	0	---
Oil Cleanliness		ISO 4406 (c)	>20/18/15	▲ **22/19/14**	20/18/12	---
