Customer Id: TESAUSTLC
Sample No.: TLC05964592
Lab Number: 05964592
Test Package: PLANT

OIL ANALYSIS REPORT

Machine Id
TRANSFER TRANSFER
Component
Lube System
Fluid
ISO 150 (--- GAL)

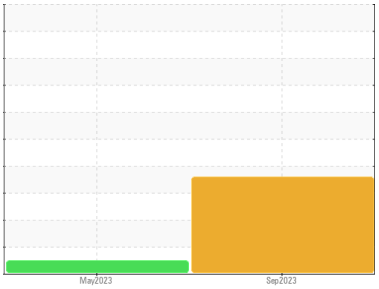
Sample Rating Trend

WEAR

Wear
The iron level is abnormal.

Contamination
There is a high amount of particulates present in the oil. There is a moderate amount of visible silt present in the sample.

We recommend you service the filters on this component if applicable. We recommend an early resample to monitor this condition.

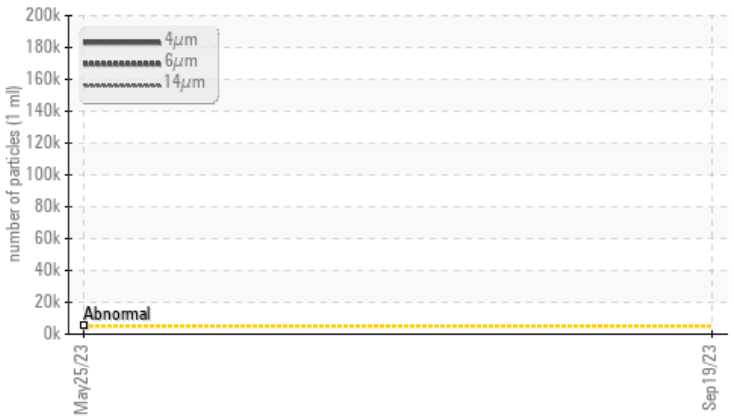
Particle Trend

Sample Status				ABNORMAL	NORMAL	---
Iron	ppm	ASTM D5185m	>20	▲ **65**	16	---
Particles >4µm		ASTM D7647	>5000	▲ **184977**	---	---
Particles >6µm		ASTM D7647	>1300	▲ **140658**	---	---
Particles >14µm		ASTM D7647	>160	▲ **11589**	---	---
Particles >21µm		ASTM D7647	>40	▲ **258**	---	---
Oil Cleanliness		ISO 4406 (c)	>19/17/14	▲ **25/24/21**	---	---
Silt	scalar	*Visual	NONE	▲ **MODER**	NONE	---

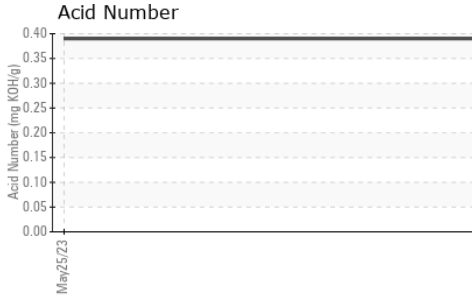
Acid Number

Fluid Condition
The AN level is acceptable for this fluid. The condition of the oil is acceptable for the time in service.

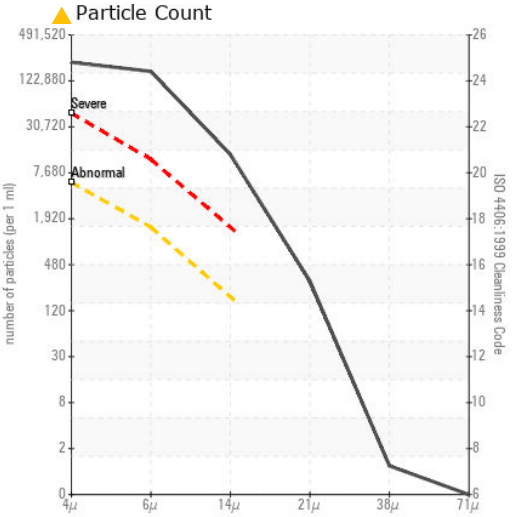
Particle Count

FLUID CLEANLINESS		method	limit/base	current	history1	history2
Particles >4µm		ASTM D7647	>5000	▲ **184977**	---	---
Particles >6µm		ASTM D7647	>1300	▲ **140658**	---	---
Particles >14µm		ASTM D7647	>160	▲ **11589**	---	---
Particles >21µm		ASTM D7647	>40	▲ **258**	---	---
Particles >38µm		ASTM D7647	>10	**1**	---	---
Particles >71µm		ASTM D7647	>3	**0**	---	---
Oil Cleanliness		ISO 4406 (c)	>19/17/14	▲ **25/24/21**	---	---
