PROBLEM SUMMARY

Area
Utility
Machine Id
FEH85AH09 Cooling Tower, Cell / Fan
Component
Gearbox
Fluid
JAX FGG-AW ISO 220 (--- GAL)

Customer Id: NOVFRANC
Sample No.: WC0822453
Lab Number: 05966271
Test Package: IND 2

OIL ANALYSIS REPORT

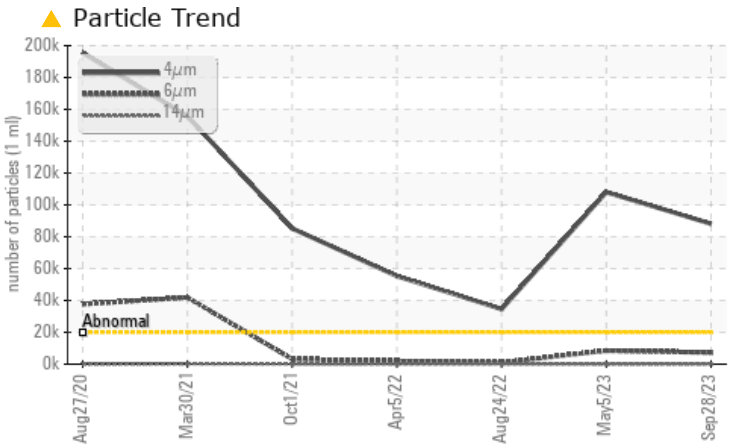
COMPONENT CONDITION SUMMARY

Sample Status				ABNORMAL	ABNORMAL	ATTENTION
Particles >4µm		ASTM D7647	>20000	▲ **88129**	▲ 108016	▲ 34579
Particles >6µm		ASTM D7647	>5000	▲ **7283**	▲ 8472	1015
Oil Cleanliness		ISO 4406 (c)	>21/19/16	▲ **24/20/13**	▲ 24/20/12	▲ 22/17/12

We recommend you service the filters on this component if applicable. Resample at the next service interval to monitor.

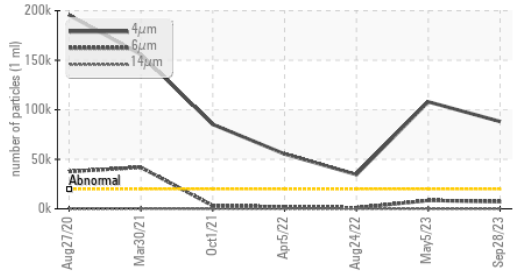
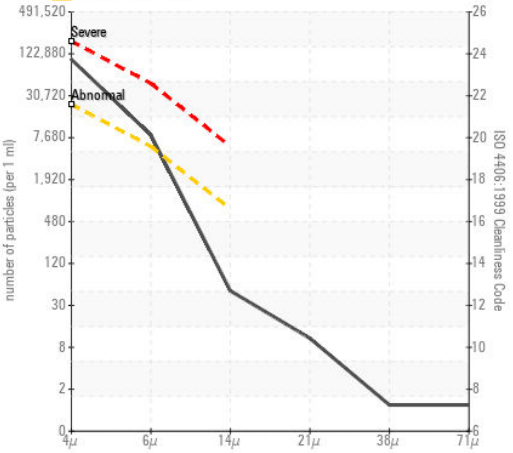
Particle Trend

Contamination
There is a high amount of silt (particulates < 14 microns in size) present in the oil.

FLUID CLEANLINESS		method	limit/base	current	history1	history2
Particles >4µm		ASTM D7647	>20000	▲ **88129**	▲ 108016	▲ 34579
Particles >6µm		ASTM D7647	>5000	▲ **7283**	▲ 8472	1015
Particles >14µm		ASTM D7647	>640	**43**	22	39
Particles >21µm		ASTM D7647	>160	**9**	2	12
Particles >38µm		ASTM D7647	>40	**1**	0	1
Particles >71µm		ASTM D7647	>10	**1**	0	0
Oil Cleanliness		ISO 4406 (c)	>21/19/16	▲ **24/20/13**	▲ 24/20/12	▲ 22/17/12

Recommendation
We recommend you service the filters on this component if applicable. Resample at the next service interval to monitor.
