OIL ANALYSIS REPORT

Machine Id
KAESER SFC 55 6059343 (S/N 1106)
Component
Compressor
Fluid
KAESER SIGMA (OEM) FG-460 (--- GAL)

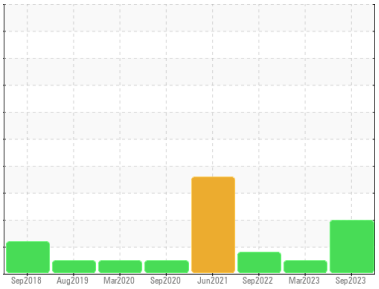
Sample Rating Trend

WATER

Sample Status				ABNORMAL	NORMAL	ATTENTION
Water	%	ASTM D6304	>0.05	▲ **0.055**	0.006	0.005
ppm Water	ppm	ASTM D6304	>500	▲ **550**	69.5	58.3
Debris	scalar	*Visual	NONE	▲ **HEAVY**	NONE	NONE

No corrective action is recommended at this time. The filter change at the time of sampling has been noted. Resample at the next service interval to monitor. We were unable to perform a particle count due to a high concentration of particles present in this sample.

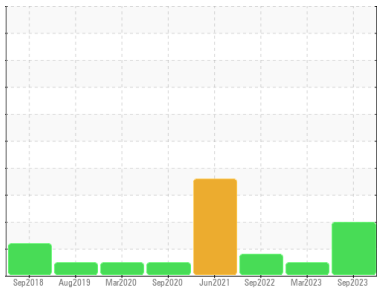
Sample Rating Trend

WATER

▲ Contamination
High concentration of visible dirt/debris present in the oil. There is a trace of moisture present in the oil.

▲ Recommendation
No corrective action is recommended at this time. The filter change at the time of sampling has been noted. Resample at the next service interval to monitor. We were unable to perform a particle count due to a high concentration of particles present in this sample.
