Area
HOTLINE/130 REVERSING MILL
Machine Id
130 MAIN DRIVE PINION-INACTIVE 1414-014-0230
Component
Gearbox
Fluid
CITGO EP COMPOUND ISO 800 (--- GAL)

Customer Id: CONMUSAL
Sample No.: KFS0004887
Lab Number: 05967763
Test Package: IND 2

OIL ANALYSIS REPORT

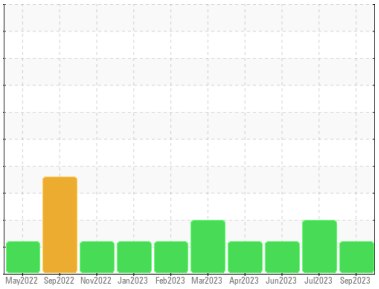
Sample Rating Trend

Sample Status				ABNORMAL	SEVERE	ABNORMAL
Particles >4µm		ASTM D7647	>20000	▲ **152408**	⬢ 168692	▲ 136344
Particles >6µm		ASTM D7647	>5000	▲ **30211**	▲ 32470	▲ 26578
Oil Cleanliness		ISO 4406 (c)	>21/19/16	▲ **24/22/15**	⬢ 25/22/15	▲ 24/22/15

We recommend you service the filters on this component. We recommend an early resample to monitor this condition. NOTE: Please provide information regarding reservoir capacity, filter type and micron rating with next sample.

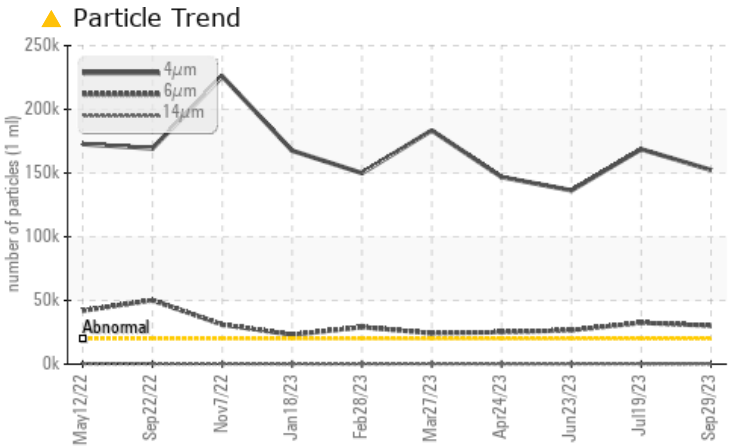
COMPONENT CONDITION SUMMARY

There is a moderate amount of silt (particulates < 14 microns in size) present in the oil.

The AN level is acceptable for this fluid. The oil is still serviceable provided that the contaminant(s) can be reduced to acceptable levels.

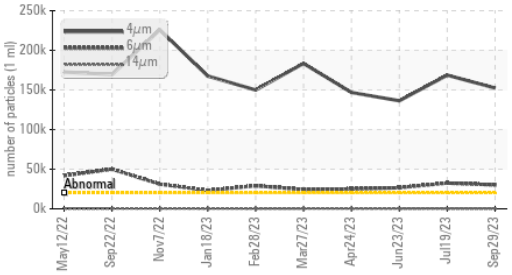
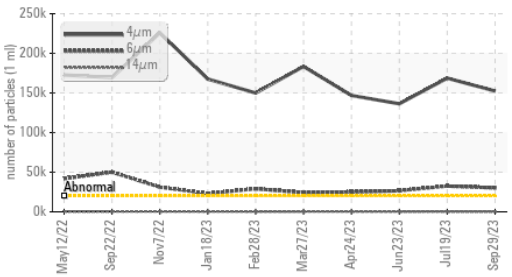
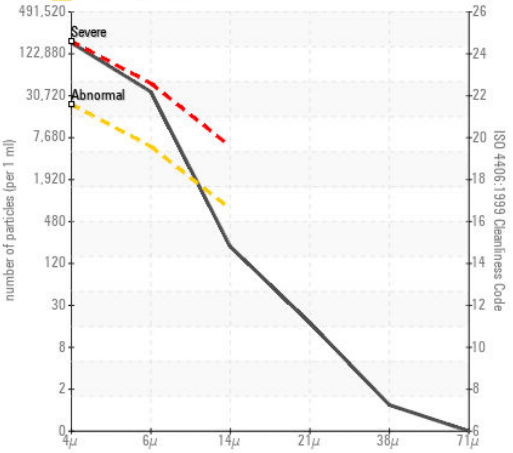
Particle Trend

FLUID CLEANLINESS		method	limit/base	current	history1	history2
Particles >4µm		ASTM D7647	>20000	▲ **152408**	⬢ 168692	▲ 136344
Particles >6µm		ASTM D7647	>5000	▲ **30211**	▲ 32470	▲ 26578
Particles >14µm		ASTM D7647	>640	**184**	232	204
Particles >21µm		ASTM D7647	>160	**15**	26	32
Particles >38µm		ASTM D7647	>40	**1**	1	2
Particles >71µm		ASTM D7647	>10	**0**	0	0
Oil Cleanliness		ISO 4406 (c)	>21/19/16	▲ **24/22/15**	⬢ 25/22/15	▲ 24/22/15

We recommend you service the filters on this component. We recommend an early resample to monitor this condition. NOTE: Please provide information regarding reservoir capacity, filter type and micron rating with next sample.
