Area
Paper Cup Machines
Machine Id
PMC 1001 POS-125 (S/N 50299)
Component
Circulating System
Fluid
SUMMIT Syngear SH-1032 320 (85 GAL)

Customer Id: DARDALTX
Sample No.: TO50001167
Lab Number: 05967773
Test Package: IND 2

OIL ANALYSIS REPORT

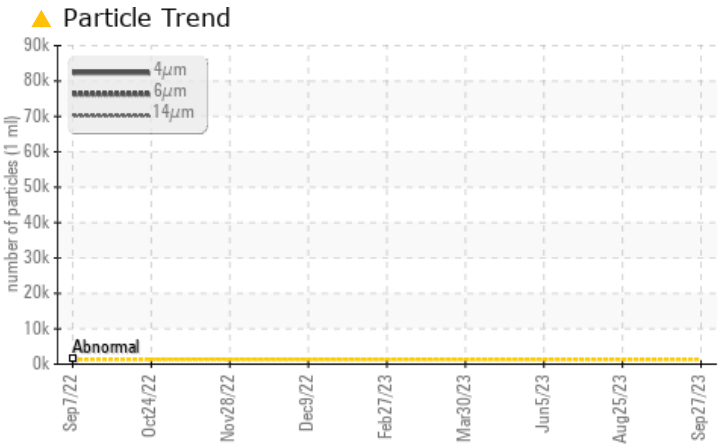
COMPONENT CONDITION SUMMARY

Sample Status				ABNORMAL	ABNORMAL	SEVERE
Particles >4µm		ASTM D7647	>1300	▲ 85812	---	---
Particles >6µm		ASTM D7647	>320	▲ 7168	---	---
Oil Cleanliness		ISO 4406 (c)	>17/15/13	▲ 24/20/12	---	---

Contamination
There is a high amount of silt (particulates < 14 microns in size) present in the oil.

We recommend you service the filters on this component if applicable. Resample at the next service interval to monitor.

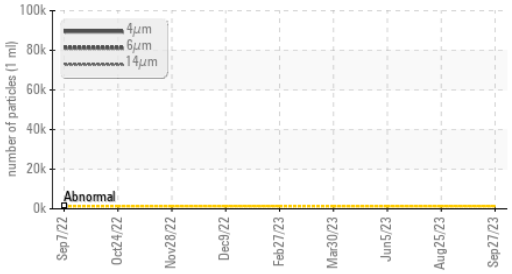
Particle Trend

FLUID CLEANLINESS		method	limit/base	current	history1	history2
Particles >4µm		ASTM D7647	>1300	▲ **85812**	---	---
Particles >6µm		ASTM D7647	>320	▲ **7168**	---	---
Particles >14µm		ASTM D7647	>80	**33**	---	---
Particles >21µm		ASTM D7647	>20	**6**	---	---
Particles >38µm		ASTM D7647	>4	**1**	---	---
Particles >71µm		ASTM D7647	>3	**1**	---	---
Oil Cleanliness		ISO 4406 (c)	>17/15/13	▲ **24/20/12**	---	---

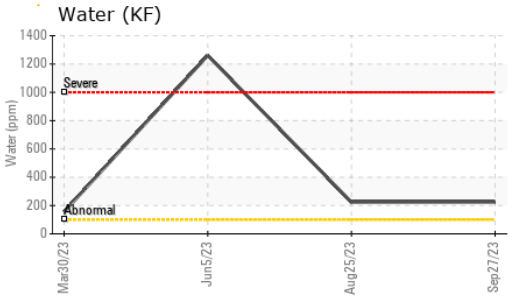
Water (KF)

CONTAMINANTS		method	limit/base	current	history1	history2
Silicon	ppm	ASTM D5185m		**3359**	10000	9829
Sodium	ppm	ASTM D5185m		**2**	2	2
Potassium	ppm	ASTM D5185m	>20	**1**	1	0
Water	%	ASTM D6304		**0.022**	0.022	▲ 0.126
ppm Water	ppm	ASTM D6304		**224.3**	223.5	▲ 1260
