Machine Id
KAESER ASD 40T 5881014 (S/N 1248)
Component
Compressor
Fluid
KAESER SIGMA (OEM) M-460 (--- GAL)

OIL ANALYSIS REPORT

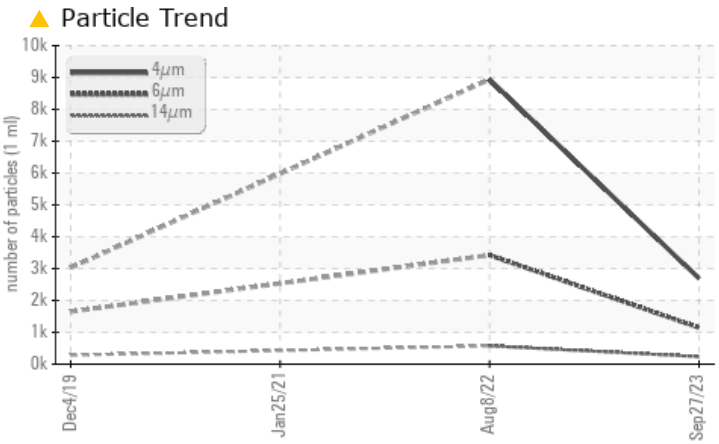
COMPONENT CONDITION SUMMARY

Sample Status				**ABNORMAL**	ABNORMAL	ABNORMAL
Particles >14µm		ASTM D7647	>80	▲ **234**	▲ 573	---
Particles >21µm		ASTM D7647	>20	▲ **96**	▲ 143	---
Particles >38µm		ASTM D7647	>4	▲ **10**	▲ 10	---
Oil Cleanliness		ISO 4406 (c)	>--/17/13	▲ **19/17/15**	▲ 20/19/16	---

▲ Contamination
There is a high amount of particulates present in the oil.

No corrective action is recommended at this time. The filter change at the time of sampling has been noted. Resample at the next service interval to monitor.

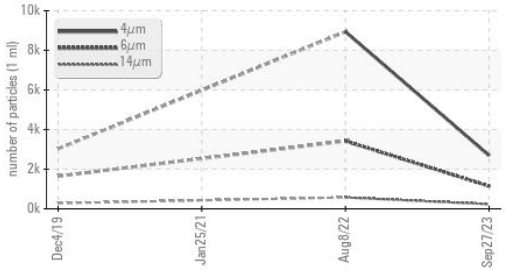
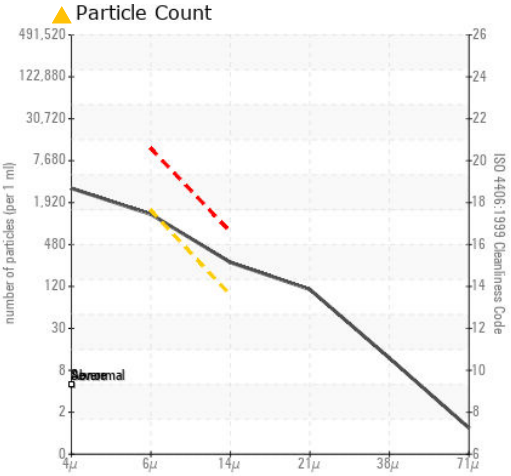
FLUID CLEANLINESS		method	limit/base	current	history1	history2
Particles >4µm		ASTM D7647		**2692**	8939	---
Particles >6µm		ASTM D7647	>1300	**1143**	▲ 3422	---
Particles >14µm		ASTM D7647	>80	▲ **234**	▲ 573	---
Particles >21µm		ASTM D7647	>20	▲ **96**	▲ 143	---
Particles >38µm		ASTM D7647	>4	▲ **10**	▲ 10	---
Particles >71µm		ASTM D7647	>3	**1**	1	---
Oil Cleanliness		ISO 4406 (c)	>--/17/13	▲ **19/17/15**	▲ 20/19/16	---

▲ Recommendation
No corrective action is recommended at this time. The filter change at the time of sampling has been noted. Resample at the next service interval to monitor.
