PROBLEM SUMMARY

Area
BLEACH O2
Machine Id
METSO BX025 PRE02 PRESS NE (S/N 0661-03-02-040-040-090)
Component
Bearing
Fluid
NOT GIVEN (4 GAL)

OIL ANALYSIS REPORT

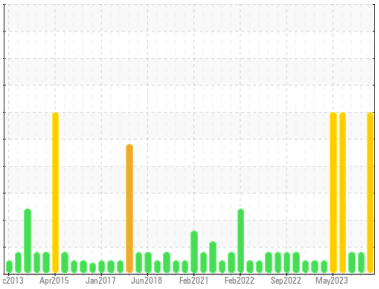
Sample Rating Trend

WEAR

Sample Status				SEVERE	ABNORMAL	ABNORMAL
Iron	ppm	ASTM D5185m	>20	**345**	79	56

We advise that you inspect for the source(s) of wear. We recommend an early resample to monitor this condition.

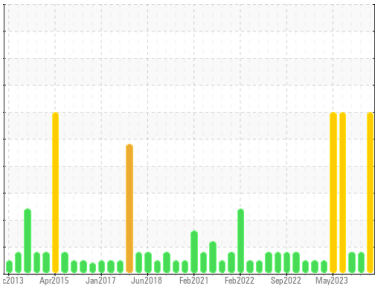
Sample Rating Trend

WEAR

Wear
The iron level is abnormal. All other component wear rates are normal.

Recommendation
We advise that you inspect for the source(s) of wear. We recommend an early resample to monitor this condition.
