OIL ANALYSIS REPORT

Area
DICK LAVY
Machine Id
DICK LAVY 4833
Component
Rear Differential
Fluid
NOT GIVEN (--- GAL)

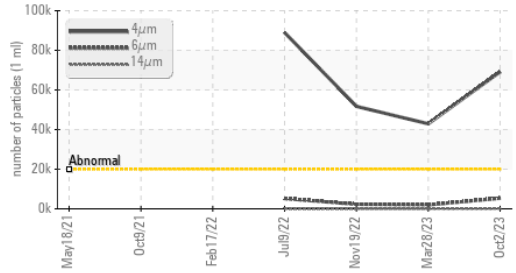
Particle Trend

Contamination
There is a high amount of silt (particulates < 14 microns in size) present in the oil.

FLUID CLEANLINESS		method	limit/base	current	history1	history2
Particles >4µm		ASTM D7647	>20000	▲ **69153**	▲ 42920	▲ 51722
Particles >6µm		ASTM D7647	>5000	▲ **5386**	2002	2280
Particles >14µm		ASTM D7647	>640	**43**	32	57
Particles >21µm		ASTM D7647	>160	**12**	8	19
Particles >38µm		ASTM D7647	>40	**1**	0	1
Particles >71µm		ASTM D7647	>10	**0**	0	0
Oil Cleanliness		ISO 4406 (c)	>21/19/16	▲ **23/20/13**	▲ 23/18/12	▲ 23/18/13

Recommendation
No corrective action is recommended at this time. Resample at the next service interval to monitor.

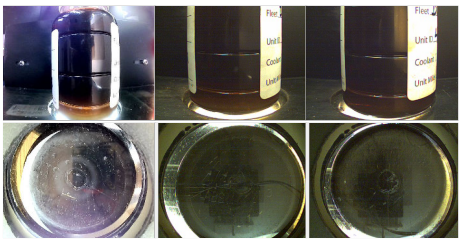
SAMPLE IMAGES	method	limit/base	current	history1	history2
Color					
Bottom

VISUAL		method	limit/base	current	history1	history2
White Metal	scalar	*Visual	NONE	**NONE**	NONE	NONE
Yellow Metal	scalar	*Visual	NONE	**NONE**	NONE	NONE
Precipitate	scalar	*Visual	NONE	**NONE**	NONE	NONE
Silt	scalar	*Visual	NONE	**NONE**	NONE	NONE
Debris	scalar	*Visual	NONE	**NONE**	NONE	NONE
Sand/Dirt	scalar	*Visual	NONE	**NONE**	NONE	NONE
Appearance	scalar	*Visual	NORML	**NORML**	NORML	NORML
Odor	scalar	*Visual	NORML	**NORML**	NORML	NORML
Emulsified Water	scalar	*Visual	>.2	**NEG**	NEG	NEG
Free Water	scalar	*Visual		**NEG**	NEG	NEG
