PROBLEM SUMMARY

Area
Extrusion
Machine Id
Press 2 Press Hydraulic Unit (S/N 70227)
Component
Hydraulic System
Fluid
AW HYDRAULIC OIL ISO 46 (2500 GAL)

OIL ANALYSIS REPORT

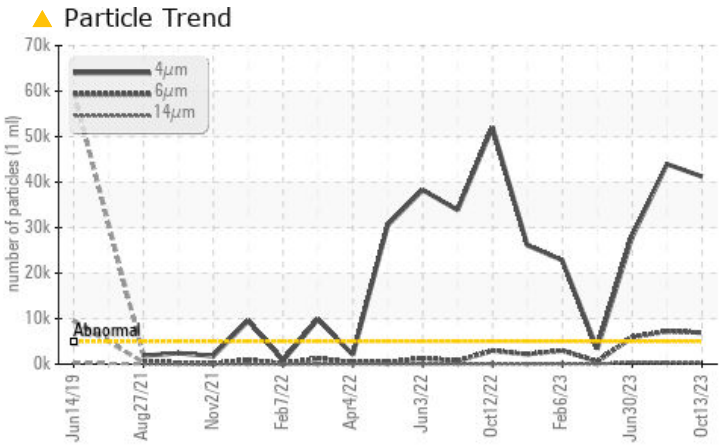
COMPONENT CONDITION SUMMARY

Sample Status				ABNORMAL	ABNORMAL	ABNORMAL
Particles >4µm		ASTM D7647	>5000	▲ **41229**	▲ 43960	▲ 27907
Particles >6µm		ASTM D7647	>1300	▲ **6923**	▲ 7239	▲ 5944
Particles >14µm		ASTM D7647	>160	▲ **297**	▲ 296	▲ 362
Particles >21µm		ASTM D7647	>40	▲ **78**	▲ 66	▲ 90
Oil Cleanliness		ISO 4406 (c)	>19/17/14	▲ **23/20/15**	▲ 23/20/15	▲ 22/20/16

There is a high amount of particulates present in the oil.

We recommend you service the filters on this component. Resample at the next service interval to monitor.

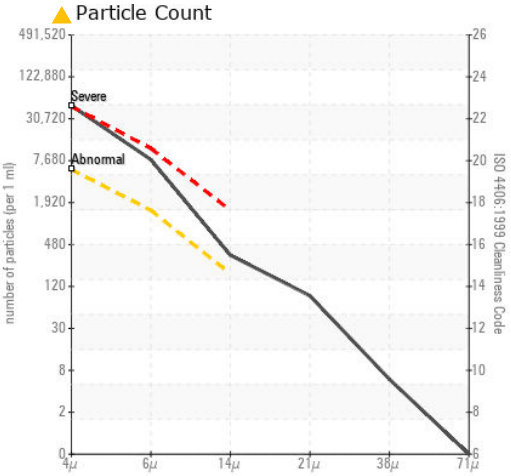
Particle Count

FLUID CLEANLINESS		method	limit/base	current	history1	history2
Particles >4µm		ASTM D7647	>5000	▲ **41229**	▲ 43960	▲ 27907
Particles >6µm		ASTM D7647	>1300	▲ **6923**	▲ 7239	▲ 5944
Particles >14µm		ASTM D7647	>160	▲ **297**	▲ 296	▲ 362
Particles >21µm		ASTM D7647	>40	▲ **78**	▲ 66	▲ 90
Particles >38µm		ASTM D7647	>10	**5**	1	4
Particles >71µm		ASTM D7647	>3	**0**	0	0
Oil Cleanliness		ISO 4406 (c)	>19/17/14	▲ **23/20/15**	▲ 23/20/15	▲ 22/20/16

We recommend you service the filters on this component. Resample at the next service interval to monitor.
