PROBLEM SUMMARY

Area
TM 11
Machine Id
TM 11 YANKEE HOOD FANS
Component
Lube System
Fluid
AW HYDRAULIC OIL ISO 68 (--- GAL)

OIL ANALYSIS REPORT

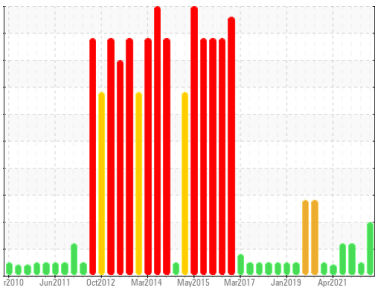
Sample Rating Trend

Sample Status				ABNORMAL	NORMAL	SEVERE
Particles >4µm		ASTM D7647	>5000	▲ **17271**	1861	⬢ 16090
Particles >6µm		ASTM D7647	>1300	▲ **4339**	141	▲ 1682
Particles >14µm		ASTM D7647	>160	▲ **406**	7	39
Particles >21µm		ASTM D7647	>40	▲ **110**	2	6
Oil Cleanliness		ISO 4406 (c)	>19/17/14	▲ **21/19/16**	18/14/10	⬢ 21/18/12

Contamination
There is a high amount of particulates present in the oil.

We recommend you service the filters on this component. Resample at the next service interval to monitor.

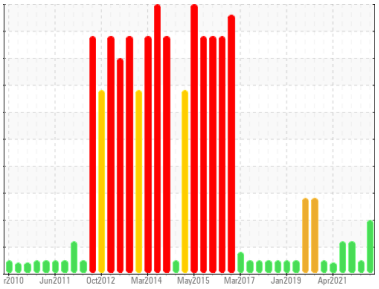
Sample Rating Trend

FLUID CLEANLINESS		method	limit/base	current	history1	history2
Particles >4µm		ASTM D7647	>5000	▲ **17271**	1861	⬢ 16090
Particles >6µm		ASTM D7647	>1300	▲ **4339**	141	▲ 1682
Particles >14µm		ASTM D7647	>160	▲ **406**	7	39
Particles >21µm		ASTM D7647	>40	▲ **110**	2	6
Particles >38µm		ASTM D7647	>10	**5**	0	0
Particles >71µm		ASTM D7647	>3	**0**	0	0
Oil Cleanliness		ISO 4406 (c)	>19/17/14	▲ **21/19/16**	18/14/10	⬢ 21/18/12

Recommendation
We recommend you service the filters on this component. Resample at the next service interval to monitor.
