# PROBLEM SUMMARY

Machine Id
## KAESER 6494783
Component
**Compressor**
Fluid
**KAESER SIGMA (OEM) M-460 (--- GAL)**

# OIL ANALYSIS REPORT

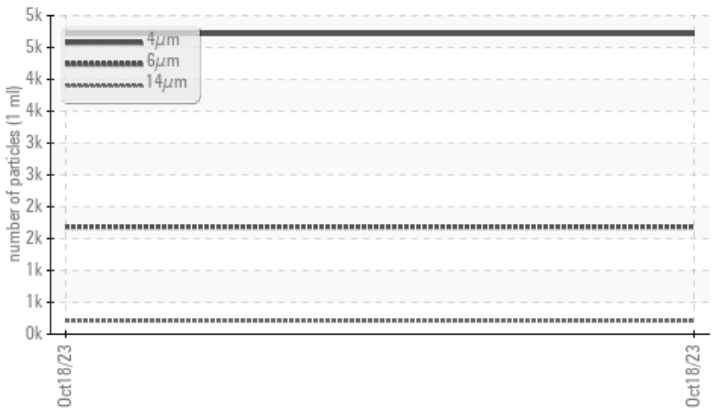
▲ Particle Trend

| Particles >6µm | | ASTM D7647 | >1300 | ▲ **1684** | --- | --- |
| Particles >14µm | | ASTM D7647 | >80 | ▲ **208** | --- | --- |
| Particles >21µm | | ASTM D7647 | >20 | ▲ **76** | --- | --- |
| Oil Cleanliness | | ISO 4406 (c) | >--/17/13 | ▲ **19/18/15** | --- | --- |

**Contamination**
There is a high amount of particulates present in the oil.

We recommend you service the filters on this component. Resample at the next service interval to monitor.

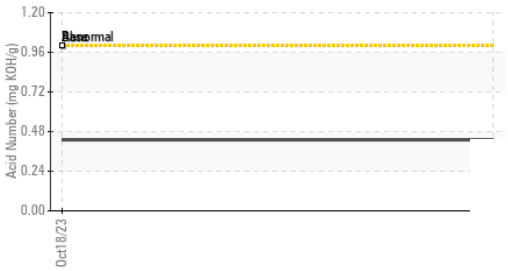
Acid Number

**Fluid Condition**
The AN level is acceptable for this fluid. The condition of the oil is acceptable for the time in service.

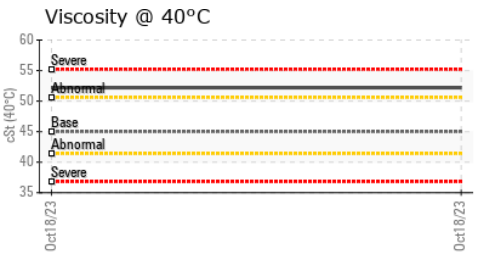
Viscosity @ 40°C

| FLUID PROPERTIES | | method | limit/base | current | history1 | history2 |
|---|---|---|---|---|---|---|
| Visc @ 40°C | cSt | ASTM D445 | 45 | **52.2** | --- | --- |

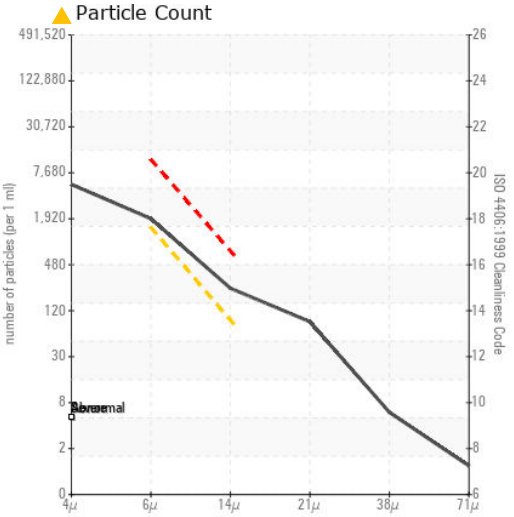
Particle Count

| FLUID CLEANLINESS | | method | limit/base | current | history1 | history2 |
|---|---|---|---|---|---|---|
| Oil Cleanliness | | ISO 4406 (c) | >--/17/13 | ▲ **19/18/15** | --- | --- |
