Machine Id
KAESER AS 30 4723514 (S/N 1162)
Component
Compressor
Fluid
KAESER SIGMA (OEM) M-460 (--- GAL)

Customer Id: BURSAN
Sample No.: KCPA007768
Lab Number: 05994365
Test Package: IND 2

OIL ANALYSIS REPORT

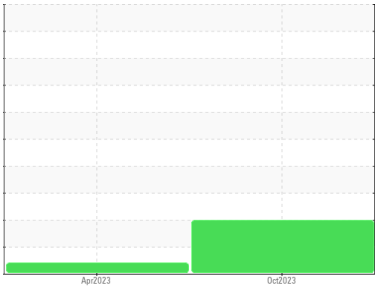
Sample Rating Trend

Sample Status				**ABNORMAL**	ABNORMAL	---
Particles >6µm		ASTM D7647	>1300	▲ **22695**	---	---
Particles >14µm		ASTM D7647	>80	▲ **2711**	---	---
Particles >21µm		ASTM D7647	>20	▲ **851**	---	---
Particles >38µm		ASTM D7647	>4	▲ **56**	---	---
Oil Cleanliness		ISO 4406 (c)	>--/17/13	▲ **23/22/19**	---	---

Contamination
There is a high amount of particulates present in the oil.

No corrective action is recommended at this time. The filter change at the time of sampling has been noted. Resample at the next service interval to monitor.

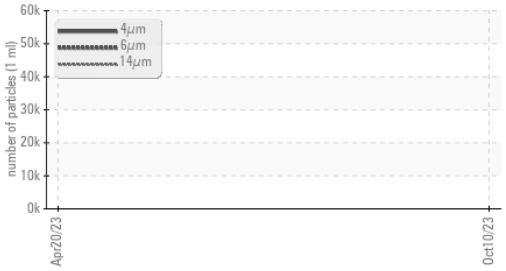
Particle Trend

FLUID CLEANLINESS		method	limit/base	current	history1	history2
Particles >4µm		ASTM D7647		**59277**	---	---
Particles >6µm		ASTM D7647	>1300	▲ **22695**	---	---
Particles >14µm		ASTM D7647	>80	▲ **2711**	---	---
Particles >21µm		ASTM D7647	>20	▲ **851**	---	---
Particles >38µm		ASTM D7647	>4	▲ **56**	---	---
Particles >71µm		ASTM D7647	>3	**4**	---	---
Oil Cleanliness		ISO 4406 (c)	>--/17/13	▲ **23/22/19**	---	---

Recommendation
No corrective action is recommended at this time. The filter change at the time of sampling has been noted. Resample at the next service interval to monitor.
