PROBLEM SUMMARY

OIL ANALYSIS REPORT

Machine Id
MYCOM C3 - PFG (S/N 16151045)
Component
Refrigeration Compressor
Fluid
SR 2033 (--- GAL)

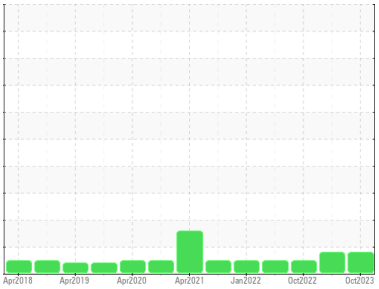
Sample Rating Trend

WEAR

▲ Ferrous Alloys

Sample Status				**MARGINAL**	ABNORMAL	NORMAL
Iron	ppm	ASTM D5185m	>8	▲ **23**	▲ 23	4

No corrective action is recommended at this time.
Resample at the next service interval to monitor.

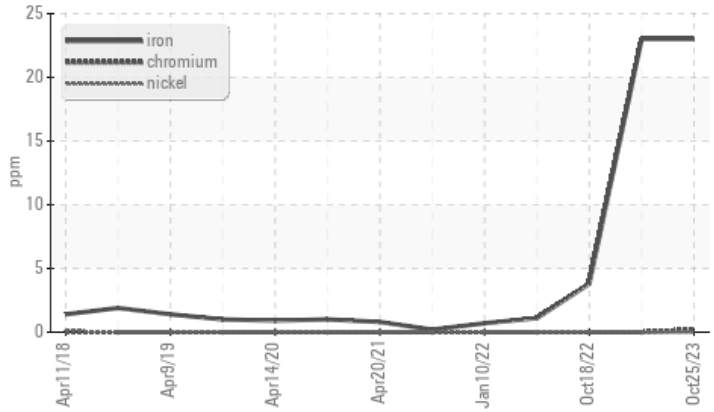
COMPONENT CONDITION SUMMARY
