Customer Id: LTILYN
Sample No.: WCMFB85535
Lab Number: 05996097
Test Package: FLEET

OIL ANALYSIS REPORT

Machine Id
KENWORTH 3161
Component
Transmission (Manual)
Fluid
NOT GIVEN (--- QTS)

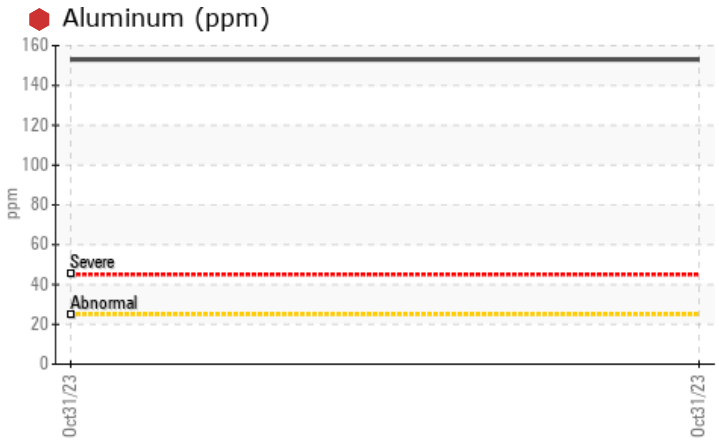
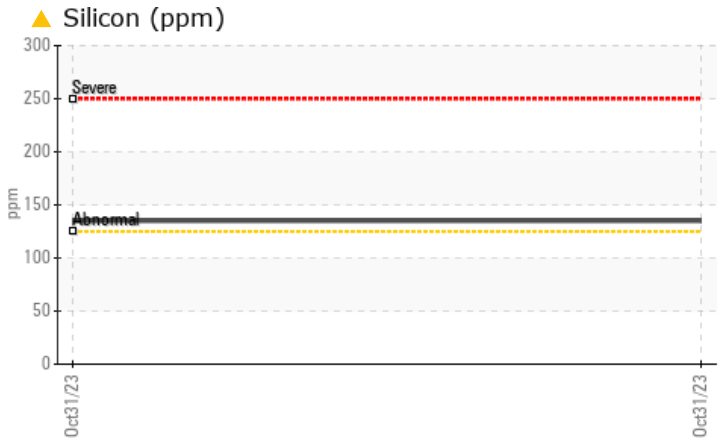
Sample Status				**SEVERE**	---	---
Aluminum	ppm	ASTM D5185m	>25	**153**	---	---
Silicon	ppm	ASTM D5185m	>125	**135**	---	---

Wear
The aluminum level is abnormal. All other component wear rates are normal.

Contamination
Elemental level of silicon (Si) above normal indicating ingress of dirt/seal material.

No corrective action is recommended at this time. We recommend an early resample to monitor this condition.

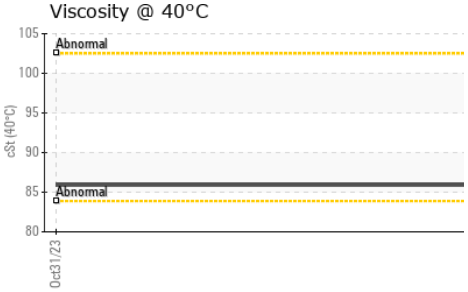
Viscosity @ 40°C

Fluid Condition
The condition of the fluid is acceptable for the time in service.
