Customer Id: WEACARQA
Sample No.: WC0877787
Lab Number: 05996686
Test Package: IND 2

OIL ANALYSIS REPORT

Area
WCLSNC
Machine Id
QC230801HY
Component
Hydraulic System
Fluid
JOHN DEERE HY-GARD HYD/TRANS (--- GAL)

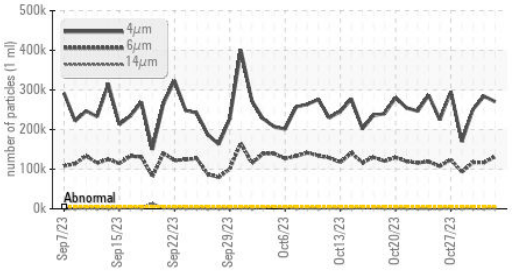
Particle Trend

Contamination
There is a high amount of particulates present in the oil.

Recommendation
We recommend you service the filters on this component. Resample at the next service interval to monitor.

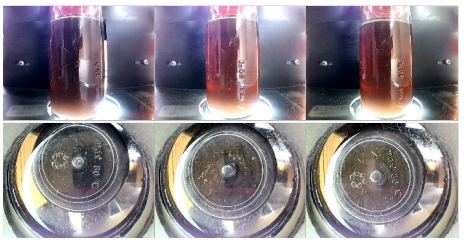
SAMPLE IMAGES	method	limit/base	current	history1	history2
Color					
Bottom

VISUAL		method	limit/base	current	history1	history2
White Metal	scalar	*Visual	NONE	**NONE**	NONE	NONE
Yellow Metal	scalar	*Visual	NONE	**NONE**	NONE	NONE
Precipitate	scalar	*Visual	NONE	**NONE**	NONE	NONE
Silt	scalar	*Visual	NONE	**NONE**	MODER	MODER
Debris	scalar	*Visual	NONE	**HEAVY**	NONE	NONE
Sand/Dirt	scalar	*Visual	NONE	**NONE**	NONE	NONE
Appearance	scalar	*Visual	NORML	**NORML**	NORML	NORML
Odor	scalar	*Visual	NORML	**NORML**	NORML	NORML
Emulsified Water	scalar	*Visual	>0.1669	**NEG**	NEG	NEG
Free Water	scalar	*Visual		**NEG**	NEG	NEG

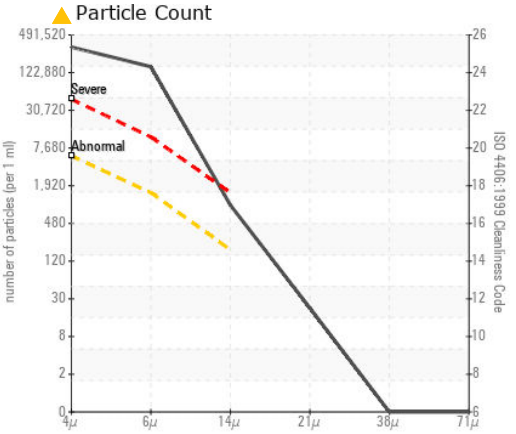
Particle Count

FLUID CLEANLINESS		method	limit/base	current	history1	history2
Particles >4µm		ASTM D7647	>5000	▲ **270482**	▲ 283987	▲ 250855
Particles >6µm		ASTM D7647	>1300	▲ **131550**	▲ 117070	▲ 117279
Particles >14µm		ASTM D7647	>160	▲ **825**	▲ 598	▲ 661
Particles >21µm		ASTM D7647	>40	**19**	13	16
Particles >38µm		ASTM D7647	>10	**0**	1	0
Particles >71µm		ASTM D7647	>3	**0**	1	0
Oil Cleanliness		ISO 4406 (c)	>19/17/14	▲ **25/24/17**	▲ 25/24/16	▲ 25/24/17
