PROBLEM SUMMARY

Area
OKLAHOMA/102/EG - EXCAVATOR
Machine Id
20.408L [OKLAHOMA^102^EG - EXCAVATOR]
Component
Hydraulic System
Fluid
MOBIL MOBILTRANS AST 30 (--- GAL)

OIL ANALYSIS REPORT

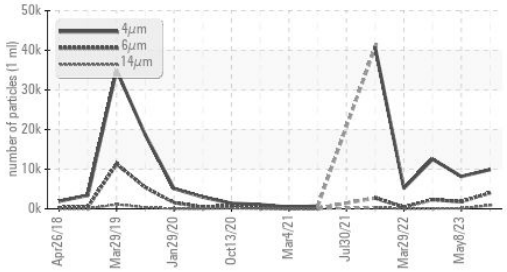
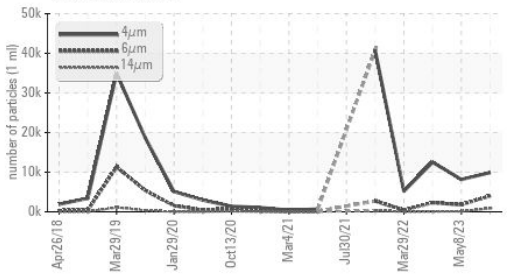
Particle Trend

Contamination
There is a light amount of silt (particulates < 14 microns in size) present in the oil.

FLUID CLEANLINESS		method	limit/base	current	history1	history2
Particles >4µm		ASTM D7647		**9899**	8163	12523
Particles >6µm		ASTM D7647	>2500	▲ **4039**	1783	2315
Particles >14µm		ASTM D7647	>640	▲ **898**	112	92
Particles >21µm		ASTM D7647	>160	▲ **272**	24	14
Particles >38µm		ASTM D7647	>40	**11**	1	0
Particles >71µm		ASTM D7647	>10	**0**	0	0
Oil Cleanliness		ISO 4406 (c)	>--/18/16	▲ **20/19/17**	20/18/14	21/18/14

Recommendation
The filter change at the time of sampling has been noted. Resample at the next service interval to monitor.

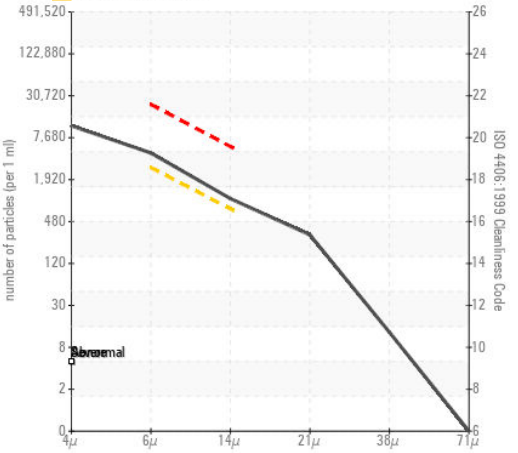
Particle Count

Sample Status				ATTENTION	NORMAL	NORMAL
Particles >6µm		ASTM D7647	>2500	▲ **4039**	1783	2315
Particles >14µm		ASTM D7647	>640	▲ **898**	112	92
Particles >21µm		ASTM D7647	>160	▲ **272**	24	14
Oil Cleanliness		ISO 4406 (c)	>--/18/16	▲ **20/19/17**	20/18/14	21/18/14

The filter change at the time of sampling has been noted. Resample at the next service interval to monitor.
