# PROBLEM SUMMARY

Area
## INTERSTITIAL - PUMP ROOM
Machine Id
## B64248 - 5C (S/N 013008-10025595-001-19054-000)
Component
**Hydraulic Power Pack**
Fluid
**AW HYDRAULIC OIL ISO 68 (--- GAL)**

# OIL ANALYSIS REPORT

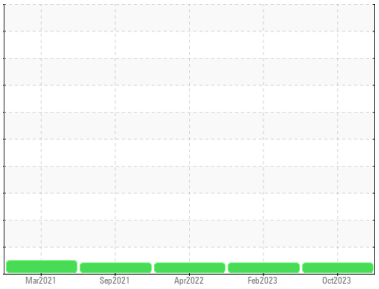
Sample Rating Trend

**VISCOSITY**

| Sample Status | | | | **ATTENTION** | ATTENTION | ATTENTION |
|---|---|---|---|---|---|---|
| Visc @ 40°C | cSt | ASTM D445 | 68 | ▲ **51.1** | ▲ 49.4 | ▲ 48.0 |

**Fluid Condition**
Viscosity of sample indicates oil is within ISO 46 range, advise investigate. Confirm oil type. The AN level is acceptable for this fluid.

Resample at the next service interval to monitor.

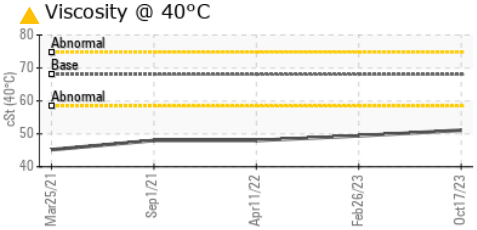
▲ Viscosity @ 40°C

| FLUID PROPERTIES | | method | limit/base | current | history1 | history2 |
|---|---|---|---|---|---|---|
| Visc @ 40°C | cSt | ASTM D445 | 68 | ▲ **51.1** | ▲ 49.4 | ▲ 48.0 |

**Recommendation**
Resample at the next service interval to monitor.
