Customer Id: IMLCAN
Sample No.: WC0699217
Lab Number: 05997955
Test Package: AOM 1

OIL ANALYSIS REPORT

Machine Id
P1-OHIO (S/N 2008024901)
Component
Hydraulic System
Fluid
PETRO CANADA PURITY FG HYDRAULIC AW 68 (800 LTR)

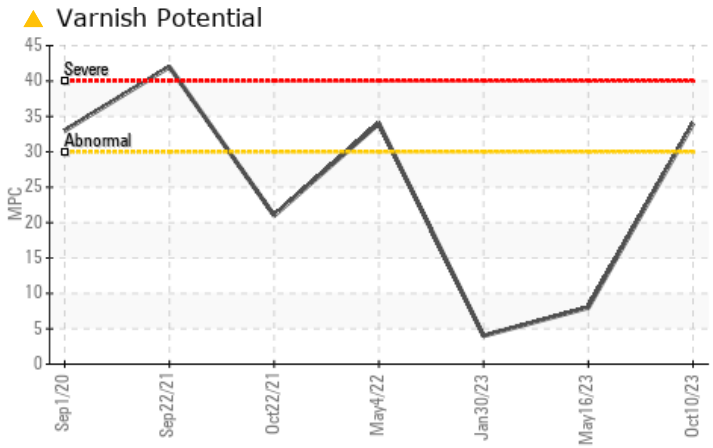
COMPONENT CONDITION SUMMARY

Sample Status				**ABNORMAL**	NORMAL	NORMAL
MPC Varnish Potential	Scale	ASTM D7843	>15	▲ **34**	8	4

Contamination
MPC (Membrane Patch Colorimetry) test indicates a moderate concentration of varnish present. The amount and size of particulates present in the system are acceptable.

No corrective action is recommended at this time.
Resample at the next service interval to monitor.

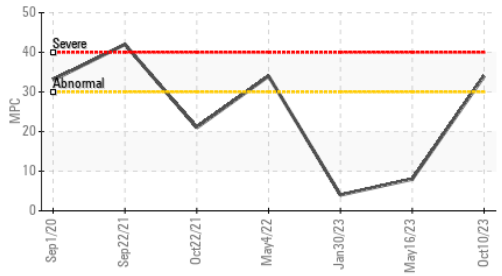
FLUID DEGRADATION		method	limit/base	current	history1	history2
Acid Number (AN)	mg KOH/g	ASTM D8045	0.26	**0.25**	0.27	0.20
Anti-Oxidant 1	%	ASTM D6971	<25	**81**	87	91
Anti-Oxidant 2	%	ASTM D6971	<25	**86**	15	25
MPC Varnish Potential	Scale	ASTM D7843	>15	▲ **34**	8	4

Recommendation
No corrective action is recommended at this time. Resample at the next service interval to monitor.

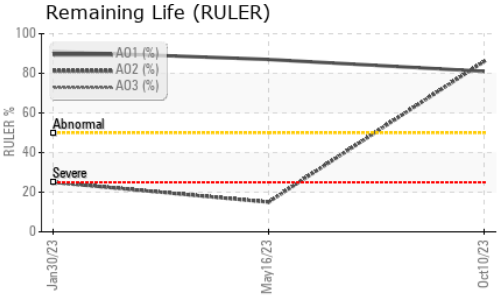
Remaining Life (RULER)

Fluid Condition
Linear Sweep Voltammetry (RULER – ASTM D6971) testing indicates normal levels of anti-oxidants present in the oil. The AN level is acceptable for this fluid. The condition of the oil is suitable for further service.

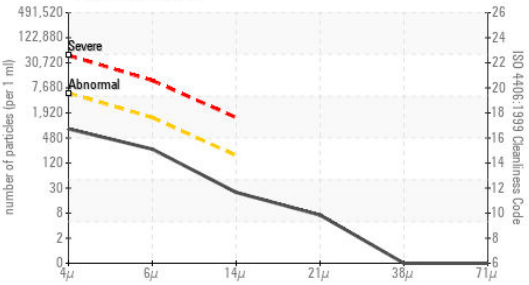
Particle Count

FLUID CLEANLINESS	method	limit/base	current	history1	history2
Particles >4µm	ASTM D7647	>5000	**696**	57	270
Particles >6µm	ASTM D7647	>1300	**228**	19	50
Particles >14µm	ASTM D7647	>160	**21**	2	4
Particles >21µm	ASTM D7647	>40	**6**	1	1
Particles >38µm	ASTM D7647	>10	**0**	0	0
Particles >71µm	ASTM D7647	>3	**0**	0	0
Oil Cleanliness	ISO 4406 (c)	>19/17/14	**17/15/12**	13/11/9	15/13/9

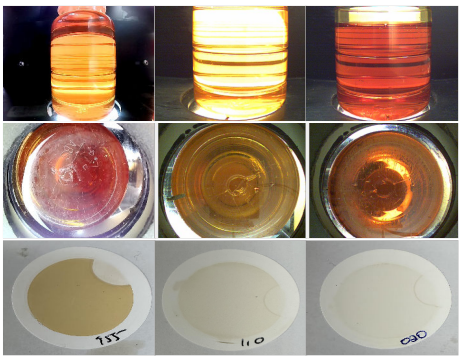
SAMPLE IMAGES	method	limit/base	current	history1	history2
Color					
Bottom					
MPC

VISUAL		method	limit/base	current	history1	history2
White Metal	scalar	*Visual	NONE	**NONE**	NONE	NONE
Yellow Metal	scalar	*Visual	NONE	**LIGHT**	NONE	NONE
Precipitate	scalar	*Visual	NONE	**NONE**	NONE	NONE
Silt	scalar	*Visual	NONE	**NONE**	NONE	NONE
Debris	scalar	*Visual	NONE	**NONE**	NONE	NONE
Sand/Dirt	scalar	*Visual	NONE	**NONE**	NONE	NONE
Appearance	scalar	*Visual	NORML	**NORML**	NORML	NORML
Odor	scalar	*Visual	NORML	**NORML**	NORML	NORML
Emulsified Water	scalar	*Visual	>0.05	**NEG**	NEG	NEG
Free Water	scalar	*Visual		**NEG**	NEG	NEG
