Customer Id: FLOCLA
Sample No.: KFS0004175
Lab Number: 05999153
Test Package: IND 2

OIL ANALYSIS REPORT

Machine Id
BMR 2ND BRIDGE END
Component
Gearbox
Fluid
ENI AGIP TELLUM VSF 320 (--- LTR)

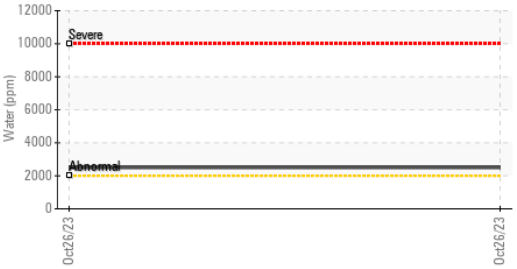
Water (KF)

Contamination
There is a light concentration of water present in the oil.

CONTAMINANTS		method	limit/base	current	history1	history2
Silicon	ppm	ASTM D5185m	>50	**11**	---	---
Sodium	ppm	ASTM D5185m		**1**	---	---
Potassium	ppm	ASTM D5185m	>20	**2**	---	---
Water	%	ASTM D6304	>0.2	▲ **0.250**	---	---
ppm Water	ppm	ASTM D6304	>2000	▲ **2500**	---	---

No corrective action is recommended at this time.
Resample at the next service interval to monitor.
