Customer Id: ETCMHOOK
Sample No.: TO60001832
Lab Number: 05999948
Test Package: IND 2

OIL ANALYSIS REPORT

Area
Marcus Hook/Cryogenic/Compressor
Machine Id
CRYOGENIC COMPRESSOR 10-C-102B
Component
Rotary Compressor
Fluid
NOT GIVEN (825 GAL)

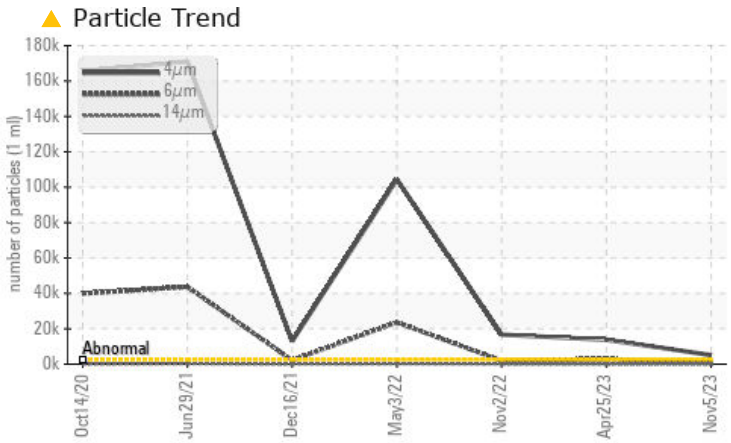
COMPONENT CONDITION SUMMARY

Sample Status				**ABNORMAL**	ABNORMAL	ABNORMAL
Particles >4µm		ASTM D7647	>2500	▲ **5127**	▲ 13791	▲ 16678
Particles >6µm		ASTM D7647	>320	▲ **743**	▲ 2843	▲ 1921
Oil Cleanliness		ISO 4406 (c)	>18/15/13	▲ **20/17/13**	▲ 21/19/12	▲ 21/18/12

We recommend you service the filters on this component if applicable. Resample at the next service interval to monitor.

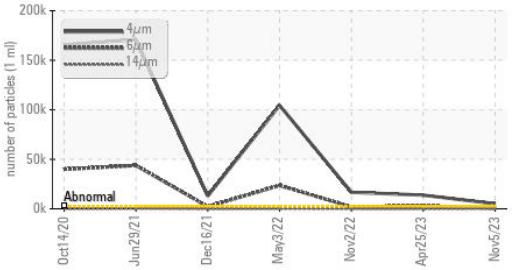
Particle Trend

Contamination
There is a high amount of silt (particulates < 14 microns in size) present in the oil.

FLUID CLEANLINESS		method	limit/base	current	history1	history2
Particles >4µm		ASTM D7647	>2500	▲ **5127**	▲ 13791	▲ 16678
Particles >6µm		ASTM D7647	>320	▲ **743**	▲ 2843	▲ 1921
Particles >14µm		ASTM D7647	>80	**42**	24	28
Particles >21µm		ASTM D7647	>20	**9**	4	5
Particles >38µm		ASTM D7647	>4	**0**	1	0
Particles >71µm		ASTM D7647	>3	**0**	0	0
Oil Cleanliness		ISO 4406 (c)	>18/15/13	▲ **20/17/13**	▲ 21/19/12	▲ 21/18/12

Recommendation
We recommend you service the filters on this component if applicable. Resample at the next service interval to monitor.
