Customer Id: UCTATRIC
Sample No.: UCH06000584
Lab Number: 06000584
Test Package: IND 2

OIL ANALYSIS REPORT

Area
TE PAG-32
Machine Id
COMP AIR D101928 - FIRST DATA
Component
Compressor

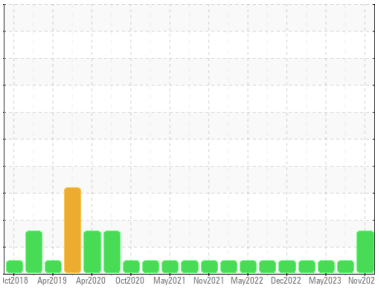
Sample Rating Trend

WATER

Contamination
There is a light concentration of water present in the oil.

We advise that you follow the water drain-off procedure for this component. Resample at the next service interval to monitor.

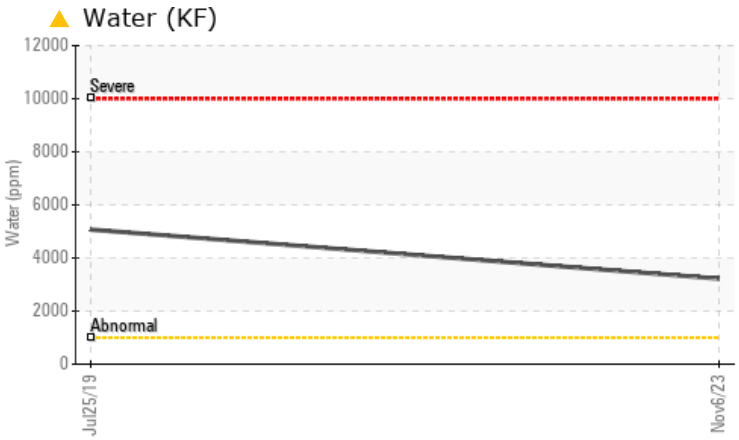
COMPONENT CONDITION SUMMARY

Sample Status				**ATTENTION**	NORMAL	NORMAL
Water	%	ASTM D6304	>0.1	▲ **0.322**	---	---
ppm Water	ppm	ASTM D6304	>1000	▲ **3220**	---	---
Emulsified Water	scalar	*Visual	>0.1	▲ **0.2%**	NEG	NEG
