Machine Id
PRESS 6 LOADER NON-FLAM
Component
Hydraulic System
Fluid
TEXACO HYDRAULIC SAFETY FLUID (--- GAL)

Customer Id: KAIRICVA
Sample No.: WC0782212
Lab Number: 06001036
Test Package: IND 2

OIL ANALYSIS REPORT

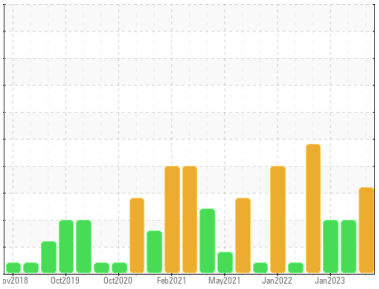
Sample Rating Trend

Sample Status				**ABNORMAL**	ABNORMAL	ABNORMAL
Particles >4µm		ASTM D7647	>5000	▲ **14346**	1442	720
Particles >6µm		ASTM D7647	>1300	▲ **7815**	786	392
Particles >14µm		ASTM D7647	>160	▲ **1330**	134	67
Particles >21µm		ASTM D7647	>40	▲ **448**	45	22
Particles >38µm		ASTM D7647	>10	▲ **69**	7	3
Particles >71µm		ASTM D7647	>3	▲ **7**	1	0
Oil Cleanliness		ISO 4406 (c)	>19/17/14	▲ **21/20/18**	18/17/14	17/16/13
Visc @ 40°C	cSt	ASTM D445	41	▲ **97.5**	▲ 180	▲ 166

We recommend you service the filters on this component. Resample at the next service interval to monitor.

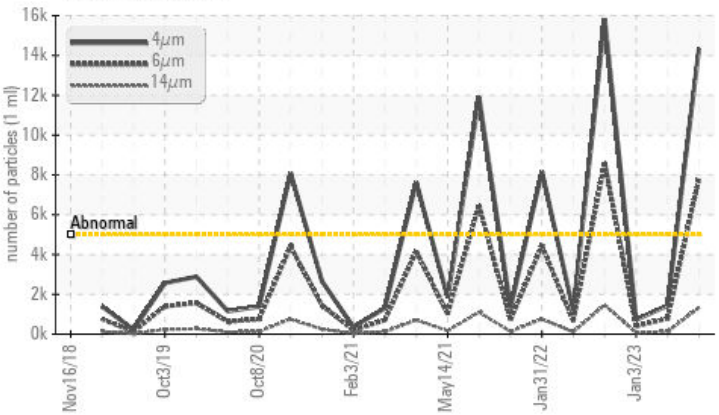
▲ Particle Trend

Contamination
There is a high amount of particulates present in the oil.

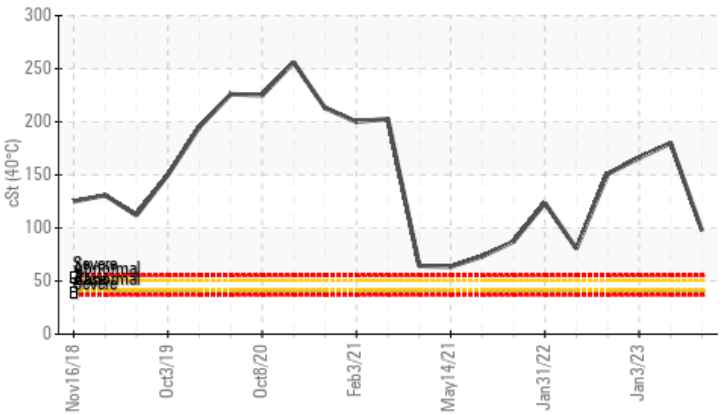
▲ Viscosity @ 40°C

Fluid Condition
The oil viscosity is higher than normal. The pH level of this fluid is within the acceptable limits. pH is 10.0. The AN level is acceptable for this fluid.

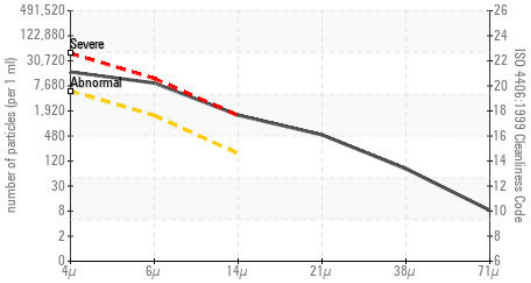
Particle Count

FLUID CLEANLINESS		method	limit/base	current	history1	history2
Particles >4µm		ASTM D7647	>5000	▲ **14346**	1442	720
Particles >6µm		ASTM D7647	>1300	▲ **7815**	786	392
Particles >14µm		ASTM D7647	>160	▲ **1330**	134	67
Particles >21µm		ASTM D7647	>40	▲ **448**	45	22
Particles >38µm		ASTM D7647	>10	▲ **69**	7	3
Particles >71µm		ASTM D7647	>3	▲ **7**	1	0
Oil Cleanliness		ISO 4406 (c)	>19/17/14	▲ **21/20/18**	18/17/14	17/16/13

Recommendation
We recommend you service the filters on this component. Resample at the next service interval to monitor.

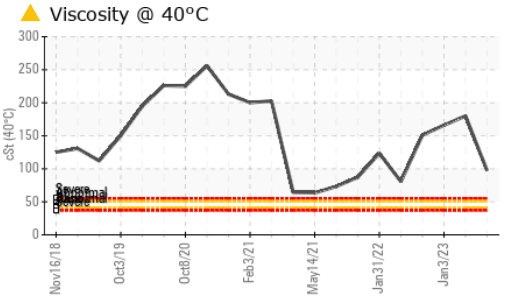
Viscosity @ 40°C

FLUID PROPERTIES		method	limit/base	current	history1	history2
pH	Scale 0-14	ASTM D1287		**10**	8.0	10.0
Visc @ 40°C	cSt	ASTM D445	41	▲ **97.5**	▲ 180	▲ 166

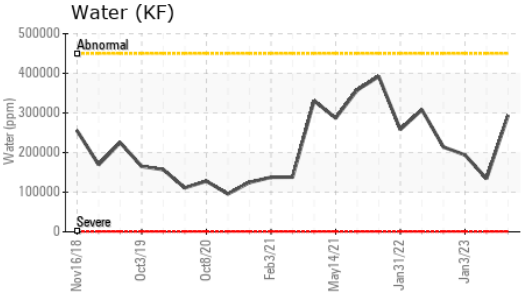
Water (KF)

CONTAMINANTS		method	limit/base	current	history1	history2
Silicon	ppm	ASTM D5185m	>15	**0**	<1	0
Sodium	ppm	ASTM D5185m		**<1**	0	3
Potassium	ppm	ASTM D5185m	>20	**<1**	<1	0
Water	%	ASTM D6304	>45	**29.4**	▲ 13.4	▲ 19.4
ppm Water	ppm	ASTM D6304	>450000	**294000**	▲ 134000	▲ 194000
