Machine Id
PRESS 2 NON-FLAM
Component
Hydraulic System
Fluid
TEXACO HYDRAULIC SAFETY FLUID (--- QTS)

Customer Id: KAIRICVA
Sample No.: WC0782215
Lab Number: 06001037
Test Package: IND 2

OIL ANALYSIS REPORT

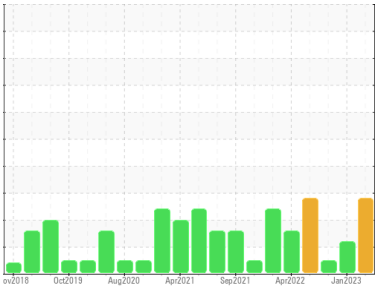
Sample Rating Trend

Sample Status				ABNORMAL	ATTENTION	NORMAL
Particles >4µm		ASTM D7647	>5000	▲ **10535**	1810	439
Particles >6µm		ASTM D7647	>1300	▲ **5739**	986	239
Particles >14µm		ASTM D7647	>160	▲ **977**	▲ 168	41
Particles >21µm		ASTM D7647	>40	▲ **329**	▲ 57	14
Particles >38µm		ASTM D7647	>10	▲ **51**	9	2
Particles >71µm		ASTM D7647	>3	▲ **5**	1	0
Oil Cleanliness		ISO 4406 (c)	>19/17/14	▲ **21/20/17**	▲ 18/17/15	16/15/13

Contamination
There is a high amount of particulates present in the oil. pH is 9.00.

We recommend you service the filters on this component. Resample at the next service interval to monitor.

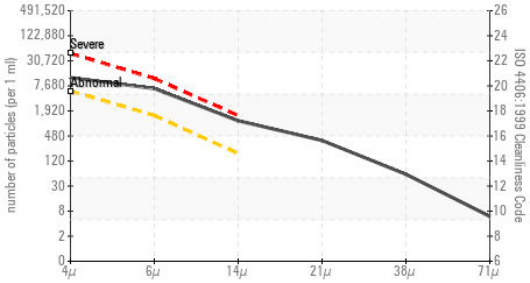
Particle Count

FLUID CLEANLINESS		method	limit/base	current	history1	history2
Particles >4µm		ASTM D7647	>5000	▲ **10535**	1810	439
Particles >6µm		ASTM D7647	>1300	▲ **5739**	986	239
Particles >14µm		ASTM D7647	>160	▲ **977**	▲ 168	41
Particles >21µm		ASTM D7647	>40	▲ **329**	▲ 57	14
Particles >38µm		ASTM D7647	>10	▲ **51**	9	2
Particles >71µm		ASTM D7647	>3	▲ **5**	1	0
Oil Cleanliness		ISO 4406 (c)	>19/17/14	▲ **21/20/17**	▲ 18/17/15	16/15/13
