Customer Id: INGPAD
Sample No.: MW0055611
Lab Number: 06001137
Test Package: MAR 2

OIL ANALYSIS REPORT

Area
RICK HARNACK
Machine Id
[RICK HARNACK] 001 685578-1
Component
Port Main Engine
Fluid
CHEVRON DELO 400 XLE 15W40 (220 GAL)

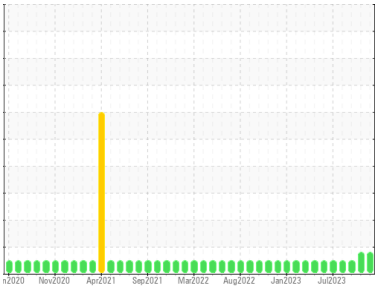
Sample Rating Trend

WEAR

▲ Non-ferrous Metals

Sample Status				**ABNORMAL**	ABNORMAL	NORMAL
Copper	ppm	ASTM D5185m	>80	▲ **84**	▲ 319	<1

Oil and filter change at the time of sampling has been noted. No corrective action is recommended at this time. Resample at the next service interval to monitor.

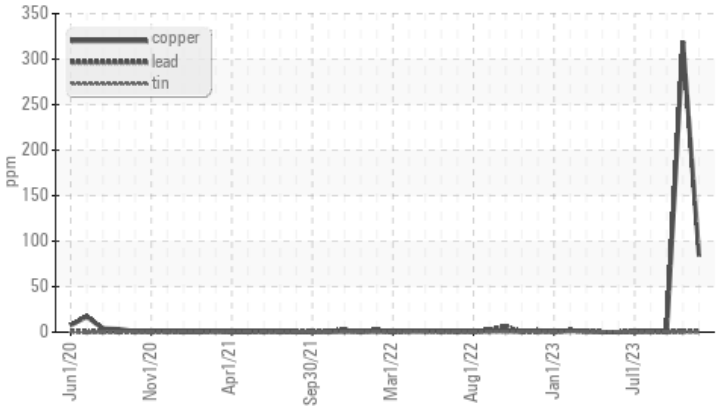
The copper level has decreased, but is still abnormal. In the absence of other significant wear metals, suspect copper due to sources other than wear (i.e. cooling core). All other component wear rates are normal.

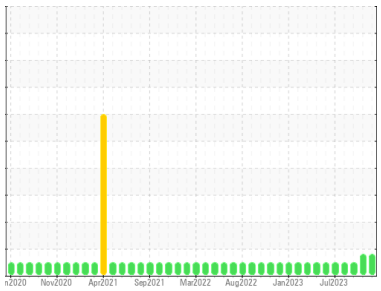
Sample Rating Trend

WEAR

Oil and filter change at the time of sampling has been noted. No corrective action is recommended at this time. Resample at the next service interval to monitor.

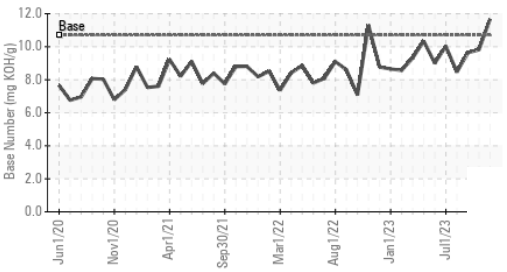
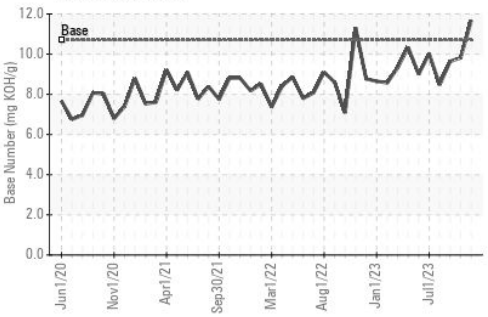
Base Number

The BN result indicates that there is suitable alkalinity remaining in the oil. The condition of the oil is suitable for further service.
