PROBLEM SUMMARY

Area
SBR
Machine Id
RX 3 (CAUSTIC) - AGITATOR
Component
Gearbox
Fluid
FUCHS CASSIDA FLUID WG 460 (1 GAL)

OIL ANALYSIS REPORT

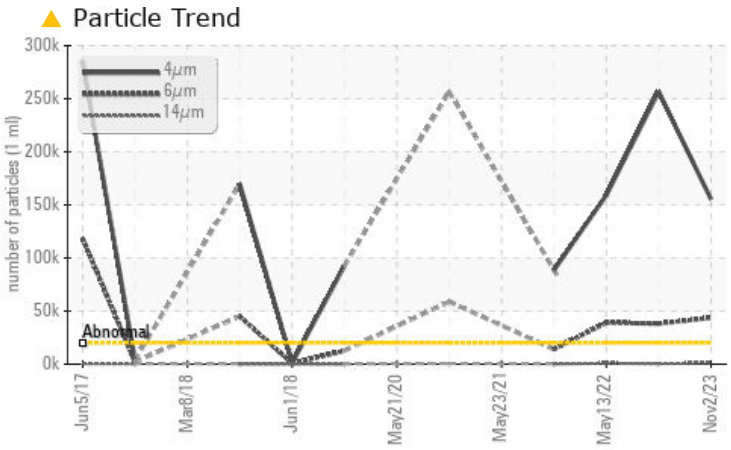
COMPONENT CONDITION SUMMARY

Sample Status				ABNORMAL	ABNORMAL	ABNORMAL
Particles >4µm		ASTM D7647	>20000	▲ **155304**	▲ 256601	▲ 159144
Particles >6µm		ASTM D7647	>5000	▲ **43636**	▲ 38083	▲ 38996
Particles >14µm		ASTM D7647	>640	▲ **997**	413	▲ 813
Oil Cleanliness		ISO 4406 (c)	>21/19/16	▲ **24/23/17**	▲ 25/22/16	▲ 24/22/17

Contamination
There is a high amount of particulates present in the oil.

We recommend you service the filters on this component if applicable. Resample at the next service interval to monitor.

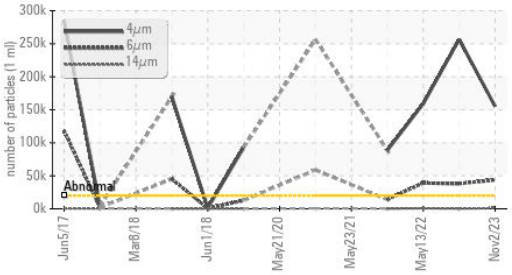
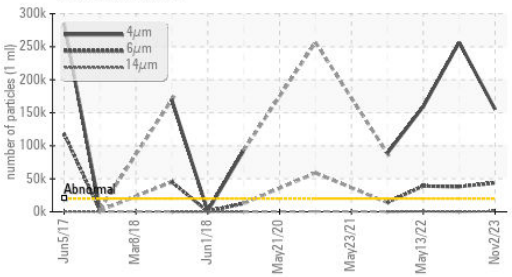
Particle Trend

FLUID CLEANLINESS		method	limit/base	current	history1	history2
Particles >4µm		ASTM D7647	>20000	▲ **155304**	▲ 256601	▲ 159144
Particles >6µm		ASTM D7647	>5000	▲ **43636**	▲ 38083	▲ 38996
Particles >14µm		ASTM D7647	>640	▲ **997**	413	▲ 813
Particles >21µm		ASTM D7647	>160	**160**	61	149
Particles >38µm		ASTM D7647	>40	**5**	10	19
Particles >71µm		ASTM D7647	>10	**1**	0	0
Oil Cleanliness		ISO 4406 (c)	>21/19/16	▲ **24/23/17**	▲ 25/22/16	▲ 24/22/17

Recommendation
We recommend you service the filters on this component if applicable. Resample at the next service interval to monitor.
