PROBLEM SUMMARY

Area
HOTLINE/130 REVERSING MILL
Machine Id
130 MAIN DRIVE PINION-INACTIVE 1414-014-0230
Component
Gearbox
Fluid
CITGO EP COMPOUND ISO 800 (--- GAL)

OIL ANALYSIS REPORT

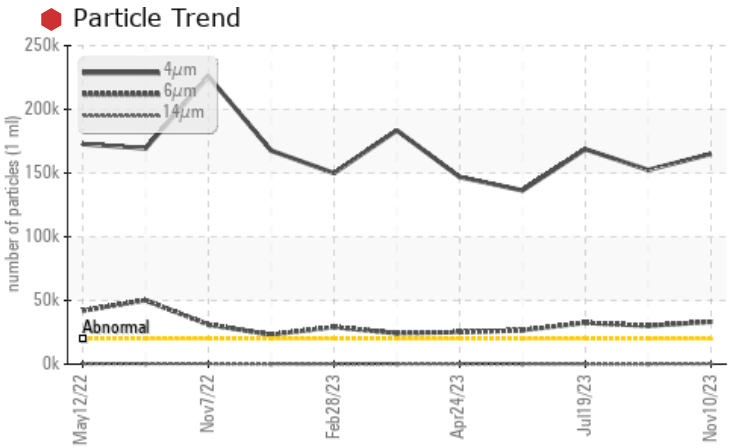
COMPONENT CONDITION SUMMARY

Sample Status				SEVERE	ABNORMAL	SEVERE
Particles >4µm		ASTM D7647	>20000	**164991**	152408	168692
Particles >6µm		ASTM D7647	>5000	**33215**	30211	32470
Oil Cleanliness		ISO 4406 (c)	>21/19/16	**25/22/15**	24/22/15	25/22/15

Check seals and/or filters for points of contaminant entry. The air breather requires service. If unrated, we recommend that you replace with a suitable micron rated and/or desiccant air breather. If rated, we recommend that you service/replace the breather. We recommend you service the filters on this component. Resample in 30-45 days to monitor this situation. NOTE: Please provide information regarding reservoir capacity, filter type and micron rating with next sample.

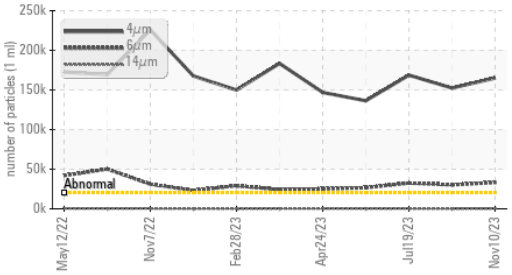
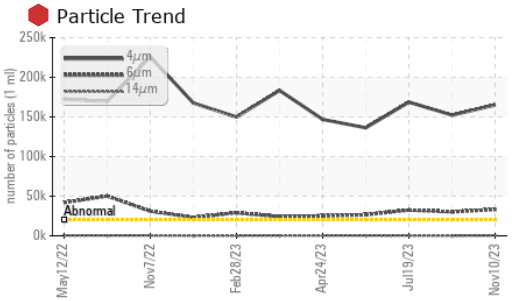
Particle Trend

There is a high amount of silt (particulates < 14 microns in size) present in the oil.

FLUID CLEANLINESS		method	limit/base	current	history1	history2
Particles >4µm		ASTM D7647	>20000	**164991**	152408	168692
Particles >6µm		ASTM D7647	>5000	**33215**	30211	32470
Particles >14µm		ASTM D7647	>640	**276**	184	232
Particles >21µm		ASTM D7647	>160	**33**	15	26
Particles >38µm		ASTM D7647	>40	**1**	1	1
Particles >71µm		ASTM D7647	>10	**0**	0	0
Oil Cleanliness		ISO 4406 (c)	>21/19/16	**25/22/15**	24/22/15	25/22/15

Check seals and/or filters for points of contaminant entry. The air breather requires service. If unrated, we recommend that you replace with a suitable micron rated and/or desiccant air breather. If rated, we recommend that you service/replace the breather. We recommend you service the filters on this component. Resample in 30-45 days to monitor this situation. NOTE: Please provide information regarding reservoir capacity, filter type and micron rating with next sample.
