Area
HOTLINE/170 REVERSING MILL
Machine Id
80 SHEAR LUBE RESERVOIR 1411-004-0280
Component
Gearbox
Fluid
CITGO COMPOUND EP 320 (165 GAL)

OIL ANALYSIS REPORT

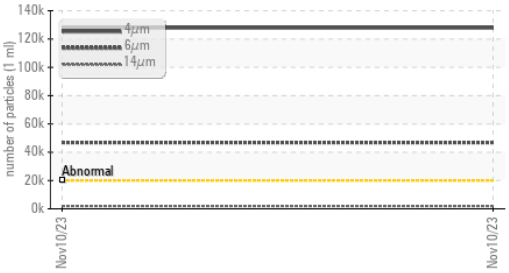
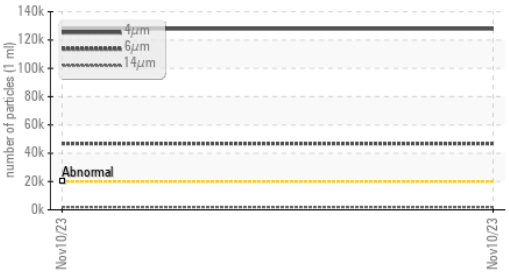
Particle Trend

Sample Status				**ABNORMAL**	---	---
Particles >4µm		ASTM D7647	>20000	▲ **127882**	---	---
Particles >6µm		ASTM D7647	>5000	▲ **46827**	---	---
Particles >14µm		ASTM D7647	>640	▲ **1941**	---	---
Particles >21µm		ASTM D7647	>160	▲ **343**	---	---
Oil Cleanliness		ISO 4406 (c)	>21/19/16	▲ **24/23/18**	---	---

▲ Contamination
There is a high amount of particulates present in the oil.

▲ Recommendation
We recommend you service the filters on this component if applicable. Resample at the next service interval to monitor.

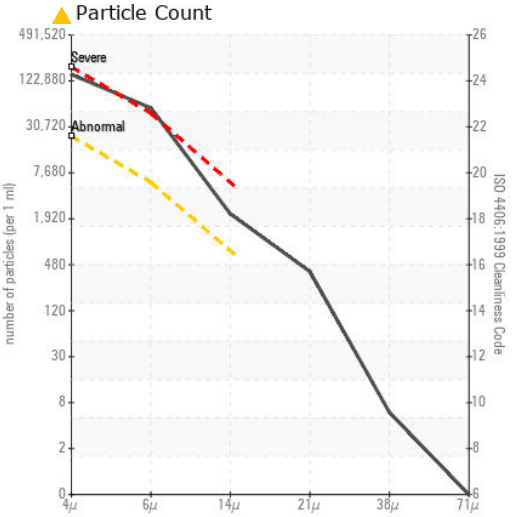
Particle Count

FLUID CLEANLINESS		method	limit/base	current	history1	history2
Particles >4µm		ASTM D7647	>20000	▲ **127882**	---	---
Particles >6µm		ASTM D7647	>5000	▲ **46827**	---	---
Particles >14µm		ASTM D7647	>640	▲ **1941**	---	---
Particles >21µm		ASTM D7647	>160	▲ **343**	---	---
Particles >38µm		ASTM D7647	>40	**5**	---	---
Particles >71µm		ASTM D7647	>10	**0**	---	---
Oil Cleanliness		ISO 4406 (c)	>21/19/16	▲ **24/23/18**	---	---
