Machine Id
MLFGPB-1 (S/N 21-211)
Component
Hydraulic Power Pack
Fluid
MOBIL DTE 25 (275 GAL)

Customer Id: WESCONSC
Sample No.: WC0782775
Lab Number: 06008303
Test Package: IND 2

OIL ANALYSIS REPORT

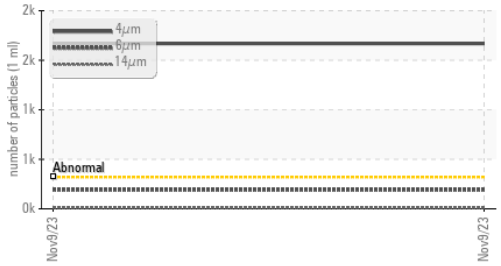
Particle Trend

Contamination
There is a high amount of silt (particulates < 14 microns in size) present in the oil.

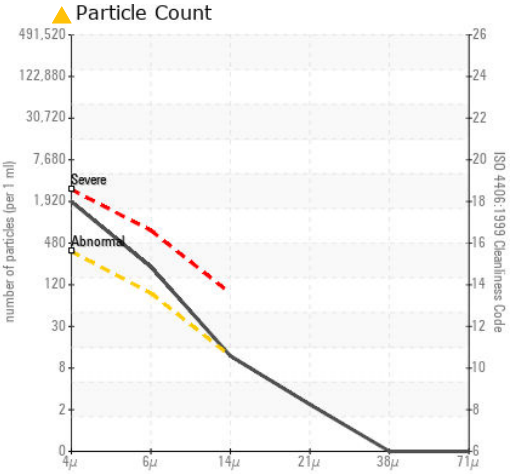
Particle Count

FLUID CLEANLINESS		method	limit/base	current	history1	history2
Particles >4µm		ASTM D7647	>320	▲ **1668**	---	---
Particles >6µm		ASTM D7647	>80	▲ **192**	---	---
Particles >14µm		ASTM D7647	>10	**10**	---	---
Particles >21µm		ASTM D7647	>3	**2**	---	---
Particles >38µm		ASTM D7647	>3	**0**	---	---
Particles >71µm		ASTM D7647	>3	**0**	---	---
Oil Cleanliness		ISO 4406 (c)	>15/13/10	▲ **18/15/10**	---	---

No corrective action is recommended at this time.
The filtering at the time of sampling has been noted.
Resample at the next service interval to monitor.
Please note that this is a corrected copy. (Customer Sample Comment: Viscosity index please)
