Machine Id
BATGPB-1 (S/N 94-512)
Component
Hydraulic Power Pack
Fluid
NOCO NOCOLUBE AW 68 (165 GAL)

Customer Id: WESCONSC
Sample No.: WC0782767
Lab Number: 06008306
Test Package: IND 2

OIL ANALYSIS REPORT

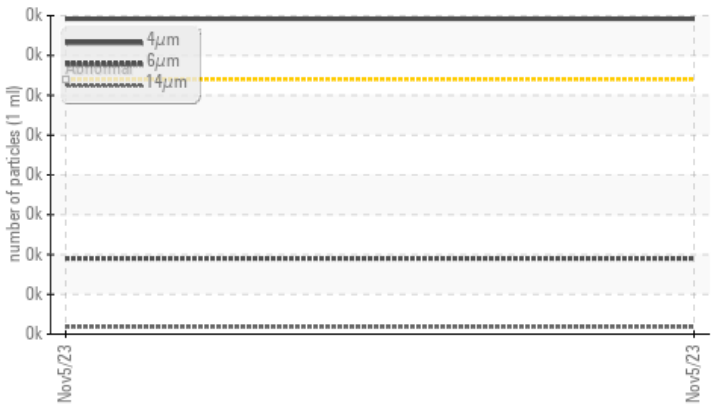
Particle Trend

Sample Status				**ATTENTION**	---	---
Particles >4µm		ASTM D7647	>320	▲ **396**	---	---
Particles >6µm		ASTM D7647	>80	▲ **95**	---	---
Oil Cleanliness		ISO 4406 (c)	>15/13/10	▲ **16/14/10**	---	---

Contamination
There is a moderate amount of silt (particulates < 14 microns in size) present in the oil.

No corrective action is recommended at this time. Resample at the next service interval to monitor. Please note that this is a corrected copy. (Customer Sample Comment: Viscosity Index please)

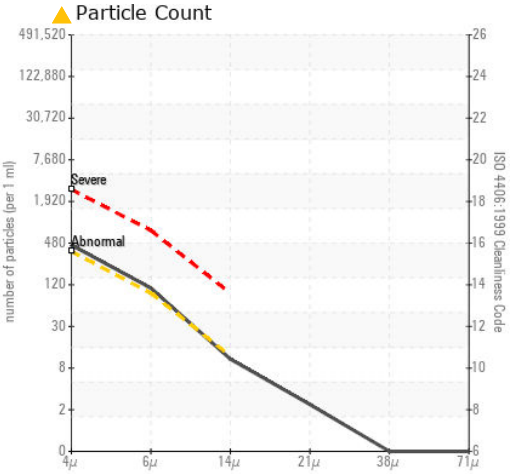
Particle Count

FLUID CLEANLINESS		method	limit/base	current	history1	history2
Particles >4µm		ASTM D7647	>320	▲ **396**	---	---
Particles >6µm		ASTM D7647	>80	▲ **95**	---	---
Particles >14µm		ASTM D7647	>10	**9**	---	---
Particles >21µm		ASTM D7647	>3	**2**	---	---
Particles >38µm		ASTM D7647	>3	**0**	---	---
Particles >71µm		ASTM D7647	>3	**0**	---	---
Oil Cleanliness		ISO 4406 (c)	>15/13/10	▲ **16/14/10**	---	---
