Customer Id: EOGMID
Sample No.: TO60001637
Lab Number: 06008415
Test Package: IND 2

OIL ANALYSIS REPORT

Area
GOLDEN BEAR LGL
Machine Id
MRC-284
Component
Compressor
Fluid
TULCO LUBSOIL GEO XL LOW ASH 40 (--- GAL)

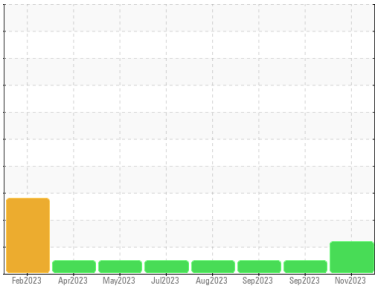
Sample Rating Trend

Sample Status				ATTENTION	NORMAL	NORMAL
Particles >4µm		ASTM D7647	>10000	▲ **12360**	4527	589
Particles >6µm		ASTM D7647	>2500	▲ **3616**	787	146
Oil Cleanliness		ISO 4406 (c)	>20/18/15	▲ **21/19/14**	19/17/12	16/14/11

No corrective action is recommended at this time.
Resample at the next service interval to monitor.

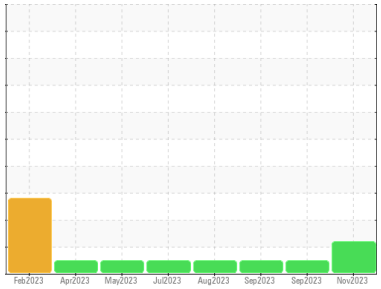
Sample Rating Trend

Contamination
There is a moderate amount of silt (particulates < 14 microns in size) present in the oil.

FLUID CLEANLINESS		method	limit/base	current	history1	history2
Particles >4µm		ASTM D7647	>10000	▲ **12360**	4527	589
Particles >6µm		ASTM D7647	>2500	▲ **3616**	787	146
Particles >14µm		ASTM D7647	>320	**108**	22	15
Particles >21µm		ASTM D7647	>80	**13**	5	5
Particles >38µm		ASTM D7647	>20	**0**	0	1
Particles >71µm		ASTM D7647	>4	**0**	0	1
Oil Cleanliness		ISO 4406 (c)	>20/18/15	▲ **21/19/14**	19/17/12	16/14/11

Recommendation
No corrective action is recommended at this time. Resample at the next service interval to monitor.
