Customer Id: PARDUBGA
Sample No.: WC0817743
Lab Number: 06008764
Test Package: IND 2

OIL ANALYSIS REPORT

Area
HPU27
Machine Id
HTS35
Component
Hydraulic System
Fluid
ESSO HYJET IV-A PLUS (30 GAL)

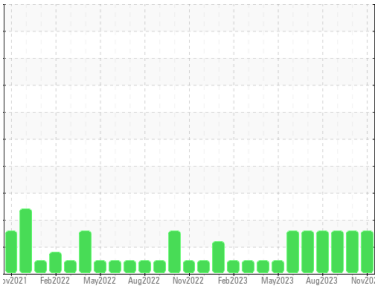
Sample Rating Trend

WATER

Sample Status				**ABNORMAL**	ABNORMAL	ABNORMAL
Water	%	ASTM D6304	>0.750	▲ **0.895**	▲ 0.925	▲ 0.822
ppm Water	ppm	ASTM D6304	>7500	▲ **8950**	▲ 9250	▲ 8220

No corrective action is recommended at this time.
Resample at the next service interval to monitor.

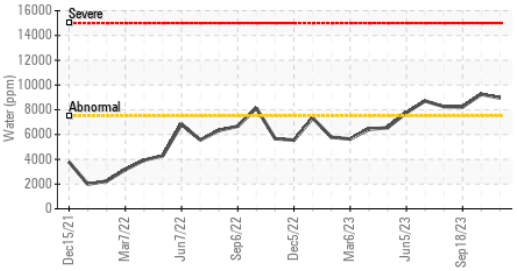
Water (KF)

There is a light concentration of water present in the oil. The system cleanliness is acceptable for your target ISO 4406 cleanliness code. The amount and size of particulates present in the system are acceptable.

CONTAMINANTS		method	limit/base	current	history1	history2
Silicon	ppm	ASTM D5185m	>15	**<1**	<1	<1
Sodium	ppm	ASTM D5185m		**4**	6	2
Potassium	ppm	ASTM D5185m	>20	**40**	33	40
Water	%	ASTM D6304	>0.750	▲ **0.895**	▲ 0.925	▲ 0.822
ppm Water	ppm	ASTM D6304	>7500	▲ **8950**	▲ 9250	▲ 8220

No corrective action is recommended at this time. Resample at the next service interval to monitor.

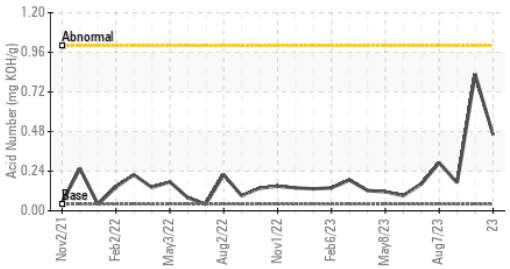
The AN level is acceptable for this fluid. The condition of the oil is suitable for further service.

FLUID DEGRADATION		method	limit/base	current	history1	history2
Acid Number (AN)	mg KOH/g	ASTM D8045	0.04	**0.461**	0.827	0.171

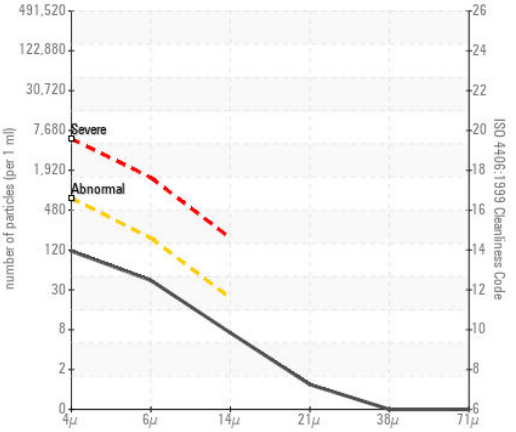
Particle Count

FLUID CLEANLINESS		method	limit/base	current	history1	history2
Particles >4µm		ASTM D7647	>640	**102**	148	110
Particles >6µm		ASTM D7647	>160	**37**	51	28
Particles >14µm		ASTM D7647	>20	**6**	9	7
Particles >21µm		ASTM D7647	>4	**1**	4	2
Particles >38µm		ASTM D7647	>3	**0**	0	0
Particles >71µm		ASTM D7647	>3	**0**	0	0
Oil Cleanliness		ISO 4406 (c)	>16/14/11	**14/12/10**	14/13/10	14/12/10
