PROBLEM SUMMARY

Area
OKLAHOMA/102/EG - SKID STEER
Machine Id
53.151L [OKLAHOMA^102^EG - SKID STEER]
Component
Hydraulic System
Fluid
MOBIL MOBILTRANS AST 30 (10 GAL)

OIL ANALYSIS REPORT

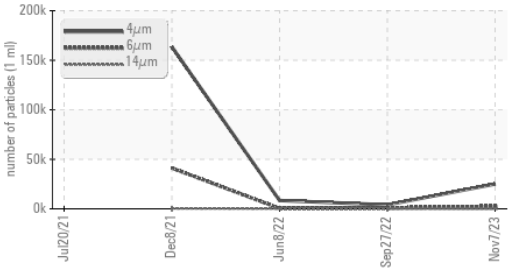
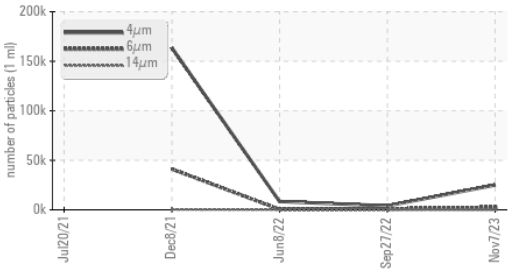
Particle Trend

Contamination
There is a moderate amount of silt (particulates < 14 microns in size) present in the oil.

FLUID CLEANLINESS		method	limit/base	current	history1	history2
Particles >4µm		ASTM D7647		**25030**	4015	8394
Particles >6µm		ASTM D7647	>2500	▲ **2617**	846	448
Particles >14µm		ASTM D7647	>640	**45**	65	28
Particles >21µm		ASTM D7647	>160	**7**	15	8
Particles >38µm		ASTM D7647	>40	**0**	1	0
Particles >71µm		ASTM D7647	>10	**0**	0	0
Oil Cleanliness		ISO 4406 (c)	>--/18/16	▲ **22/19/13**	19/17/13	20/16/12

Recommendation
No corrective action is recommended at this time. The filter change at the time of sampling has been noted. Resample at the next service interval to monitor.
