Customer Id: IDEATLGA
Sample No.: IL06009302
Lab Number: 06009302
Test Package: FLEET

OIL ANALYSIS REPORT

Machine Id
NN874499
Component
Diesel Engine
Fluid
NOT GIVEN (--- GAL)

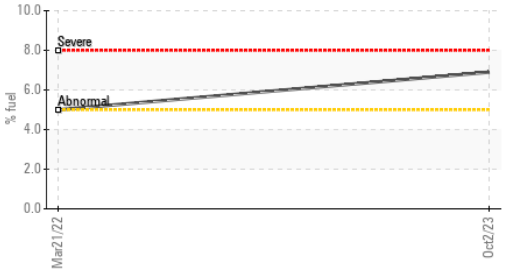
Fuel Dilution

Contamination
There is a moderate amount of fuel present in the oil. Elevated aluminum (Al) and/or lead (Pb) and potassium (K) levels in your metals analysis are likely a result of solder flux release into the lubricant and is common on new equipment/components.

CONTAMINANTS		method	limit/base	current	history1	history2
Silicon	ppm	ASTM D5185m	>25	**10**	▲ 39	---
Sodium	ppm	ASTM D5185m		**4**	5	---
Potassium	ppm	ASTM D5185m	>20	**41**	46	---
Fuel	%	ASTM D3524	>5	▲ **6.9**	▲ 5.0	---

Recommendation
We advise that you check the fuel injection system. We recommend an early resample to monitor this condition.

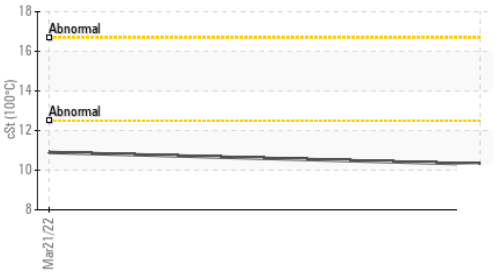
Viscosity @ 100°C

Fluid Condition
Fuel is present in the oil and is lowering the viscosity. The BN result indicates that there is suitable alkalinity remaining in the oil.

FLUID PROPERTIES		method	limit/base	current	history1	history2
Visc @ 100°C	cSt	ASTM D445		▲ **10.3**	▲ 10.9	---
