Area
412
Machine Id
621 BANBURY MOTOR
Component
Inboard Journal Bearing
Fluid
ESSO NUTO H ISO 68 (1 QTS)

Customer Id: BRIDES
Sample No.: WC0838934
Lab Number: 06009504
Test Package: IND 2

OIL ANALYSIS REPORT

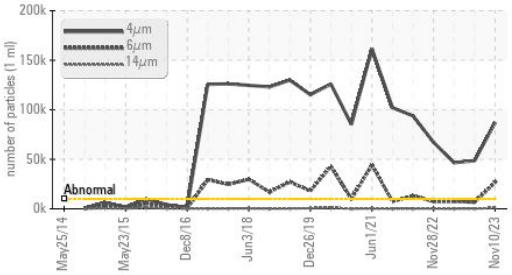
Particle Trend

There is a high amount of particulates present in the oil.

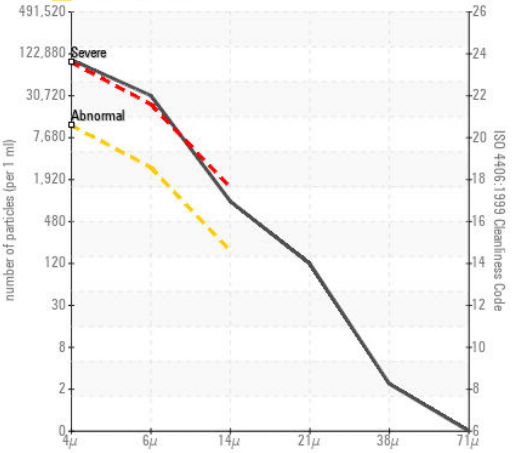
Particle Count

FLUID CLEANLINESS		method	limit/base	current	history1	history2
Particles >4µm		ASTM D7647	>10000	▲ **86966**	▲ 48559	▲ 46582
Particles >6µm		ASTM D7647	>2500	▲ **26743**	▲ 6672	▲ 7658
Particles >14µm		ASTM D7647	>160	▲ **818**	▲ 210	69
Particles >21µm		ASTM D7647	>40	▲ **105**	▲ 58	7
Particles >38µm		ASTM D7647	>10	**2**	2	0
Particles >71µm		ASTM D7647	>3	**0**	0	0
Oil Cleanliness		ISO 4406 (c)	>20/18/14	▲ **24/22/17**	▲ 23/20/15	▲ 23/20/13

No corrective action is recommended at this time. The oil change at the time of sampling has been noted. Resample at the next service interval to monitor.
