Customer Id: BRIDES
Sample No.: WC0838845
Lab Number: 06009506
Test Package: IND 2

OIL ANALYSIS REPORT

Area
412
Machine Id
72 BANBURY MOTOR
Component
Inboard Journal Bearing
Fluid
ESSO NUTO H ISO 68 (1 QTS)

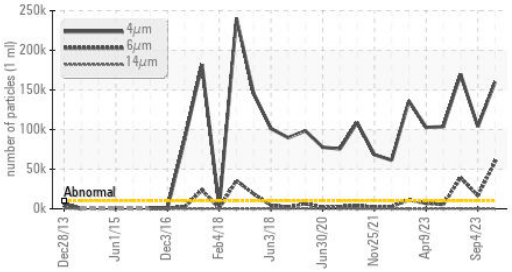
Particle Trend

Sample Status				**ABNORMAL**	ABNORMAL	ABNORMAL
Particles >4µm		ASTM D7647	>10000	▲ **159875**	▲ 103815	▲ 169704
Particles >6µm		ASTM D7647	>2500	▲ **59241**	▲ 16653	▲ 39418
Particles >14µm		ASTM D7647	>160	▲ **353**	92	132
Oil Cleanliness		ISO 4406 (c)	>20/18/14	▲ **24/23/16**	▲ 24/21/14	▲ 25/22/14

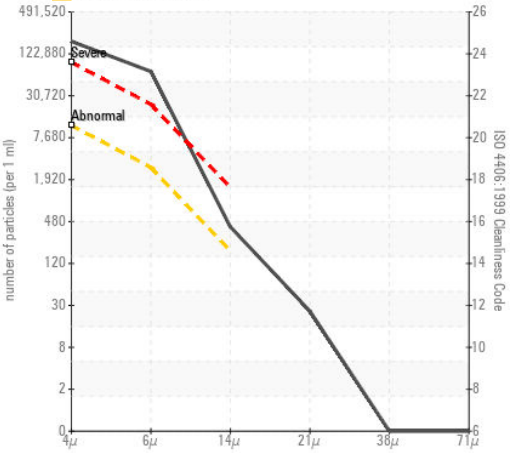
Particle Count

Contamination
There is a high amount of particulates present in the oil.

FLUID CLEANLINESS		method	limit/base	current	history1	history2
Particles >4µm		ASTM D7647	>10000	▲ **159875**	▲ 103815	▲ 169704
Particles >6µm		ASTM D7647	>2500	▲ **59241**	▲ 16653	▲ 39418
Particles >14µm		ASTM D7647	>160	▲ **353**	92	132
Particles >21µm		ASTM D7647	>40	**22**	11	9
Particles >38µm		ASTM D7647	>10	**0**	0	1
Particles >71µm		ASTM D7647	>3	**0**	0	0
Oil Cleanliness		ISO 4406 (c)	>20/18/14	▲ **24/23/16**	▲ 24/21/14	▲ 25/22/14

Recommendation
No corrective action is recommended at this time. The oil change at the time of sampling has been noted. Resample at the next service interval to monitor.
