Customer Id: BRIDES
Sample No.: WC0838930
Lab Number: 06009508
Test Package: IND 2

OIL ANALYSIS REPORT

Area
412
Machine Id
73 BANBURY MOTOR
Component
Inboard Journal Bearing
Fluid
ESSO NUTO H ISO 68 (1 QTS)

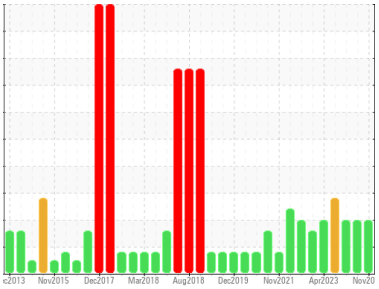
Sample Rating Trend

ISO

Sample Status				ABNORMAL	ABNORMAL	ABNORMAL
Particles >4µm		ASTM D7647	>10000	▲ **148059**	▲ 141971	▲ 175644
Particles >6µm		ASTM D7647	>2500	▲ **75897**	▲ 54036	▲ 61135
Particles >14µm		ASTM D7647	>160	▲ **1393**	▲ 597	▲ 822
Particles >21µm		ASTM D7647	>40	▲ **232**	▲ 57	▲ 124
Oil Cleanliness		ISO 4406 (c)	>20/18/14	▲ **24/23/18**	▲ 24/23/16	▲ 25/23/17

No corrective action is recommended at this time. The oil change at the time of sampling has been noted. Resample at the next service interval to monitor.

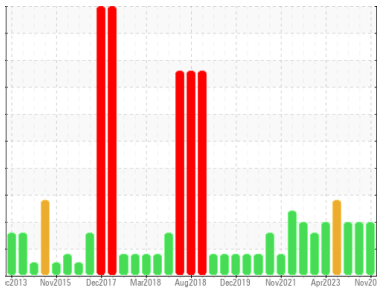
Sample Rating Trend

ISO

There is a high amount of particulates present in the oil.

No corrective action is recommended at this time. The oil change at the time of sampling has been noted. Resample at the next service interval to monitor.

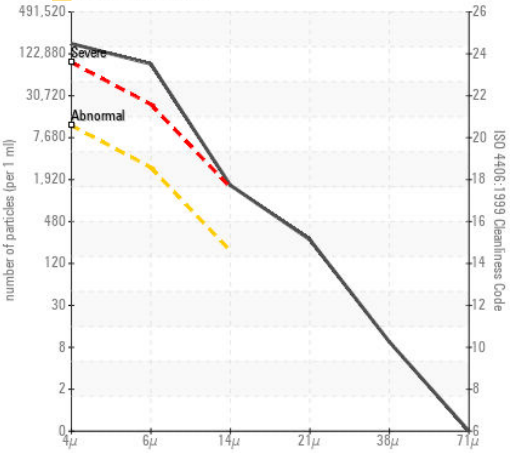
Particle Count

FLUID CLEANLINESS		method	limit/base	current	history1	history2
Particles >4µm		ASTM D7647	>10000	▲ **148059**	▲ 141971	▲ 175644
Particles >6µm		ASTM D7647	>2500	▲ **75897**	▲ 54036	▲ 61135
Particles >14µm		ASTM D7647	>160	▲ **1393**	▲ 597	▲ 822
Particles >21µm		ASTM D7647	>40	▲ **232**	▲ 57	▲ 124
Particles >38µm		ASTM D7647	>10	**8**	0	2
Particles >71µm		ASTM D7647	>3	**0**	0	0
Oil Cleanliness		ISO 4406 (c)	>20/18/14	▲ **24/23/18**	▲ 24/23/16	▲ 25/23/17
