Customer Id: BRIDES
Sample No.: WC0838888
Lab Number: 06009509
Test Package: IND 2

OIL ANALYSIS REPORT

Area
412
Machine Id
621 BANBURY MOTOR
Component
Outboard Journal Bearing
Fluid
ESSO NUTO H ISO 68 (1 QTS)

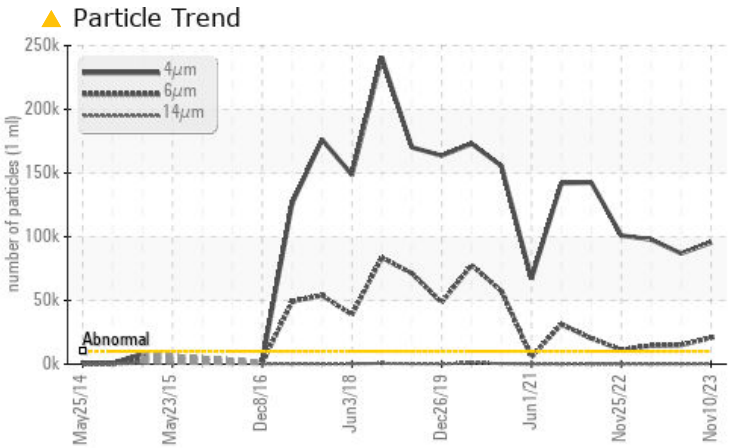
COMPONENT CONDITION SUMMARY

Sample Status				**ABNORMAL**	ABNORMAL	ABNORMAL
Particles >4µm		ASTM D7647	>10000	▲ **95377**	▲ 86889	▲ 97761
Particles >6µm		ASTM D7647	>2500	▲ **20776**	▲ 14977	▲ 14520
Particles >14µm		ASTM D7647	>160	▲ **367**	▲ 170	142
Particles >21µm		ASTM D7647	>40	▲ **44**	18	16
Oil Cleanliness		ISO 4406 (c)	>20/18/14	▲ **24/22/16**	▲ 24/21/15	▲ 24/21/14

Contamination
There is a high amount of particulates present in the oil.

No corrective action is recommended at this time. The oil change at the time of sampling has been noted. Resample at the next service interval to monitor.

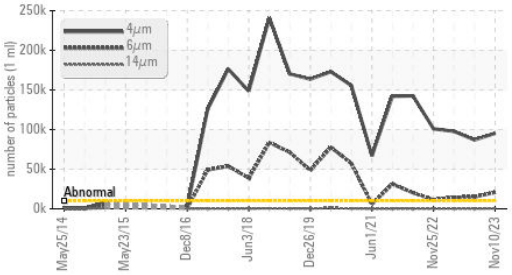
Particle Trend

FLUID CLEANLINESS		method	limit/base	current	history1	history2
Particles >4µm		ASTM D7647	>10000	▲ **95377**	▲ 86889	▲ 97761
Particles >6µm		ASTM D7647	>2500	▲ **20776**	▲ 14977	▲ 14520
Particles >14µm		ASTM D7647	>160	▲ **367**	▲ 170	142
Particles >21µm		ASTM D7647	>40	▲ **44**	18	16
Particles >38µm		ASTM D7647	>10	**0**	0	0
Particles >71µm		ASTM D7647	>3	**0**	0	0
Oil Cleanliness		ISO 4406 (c)	>20/18/14	▲ **24/22/16**	▲ 24/21/15	▲ 24/21/14

Recommendation
No corrective action is recommended at this time. The oil change at the time of sampling has been noted. Resample at the next service interval to monitor.
