Customer Id: BRIDES
Sample No.: WC0838865
Lab Number: 06009515
Test Package: IND 2

OIL ANALYSIS REPORT

Area
412
Machine Id
74 BANBURY MOTOR
Component
Outboard Journal Bearing
Fluid
ESSO NUTO H ISO 68 (1 QTS)

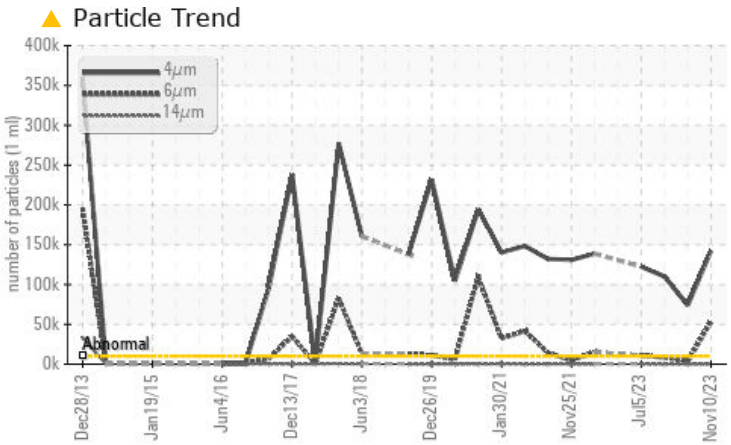
COMPONENT CONDITION SUMMARY

Sample Status				**ABNORMAL**	ABNORMAL	ABNORMAL
Particles >4µm		ASTM D7647	>10000	▲ **142163**	▲ 74030	▲ 110082
Particles >6µm		ASTM D7647	>2500	▲ **53035**	▲ 3338	▲ 8419
Oil Cleanliness		ISO 4406 (c)	>20/18/14	▲ **24/23/14**	▲ 23/19/11	▲ 24/20/12

There is a high amount of silt (particulates < 14 microns in size) present in the oil.

The oil change at the time of sampling has been noted. No corrective action is recommended at this time. Resample at the next service interval to monitor.

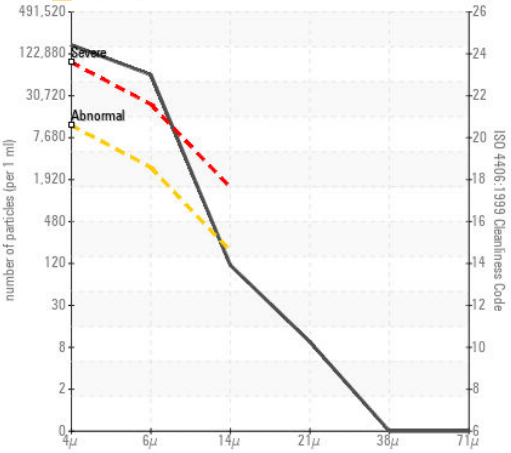
Particle Count

FLUID CLEANLINESS		method	limit/base	current	history1	history2
Particles >4µm		ASTM D7647	>10000	▲ **142163**	▲ 74030	▲ 110082
Particles >6µm		ASTM D7647	>2500	▲ **53035**	▲ 3338	▲ 8419
Particles >14µm		ASTM D7647	>160	**100**	11	38
Particles >21µm		ASTM D7647	>40	**8**	1	8
Particles >38µm		ASTM D7647	>10	**0**	0	0
Particles >71µm		ASTM D7647	>3	**0**	0	0
Oil Cleanliness		ISO 4406 (c)	>20/18/14	▲ **24/23/14**	▲ 23/19/11	▲ 24/20/12

The oil change at the time of sampling has been noted. No corrective action is recommended at this time. Resample at the next service interval to monitor.
